River Trent at the Catton Hall Estate – Hydromorphic Audit and Appraisal

Final Report

August 2012

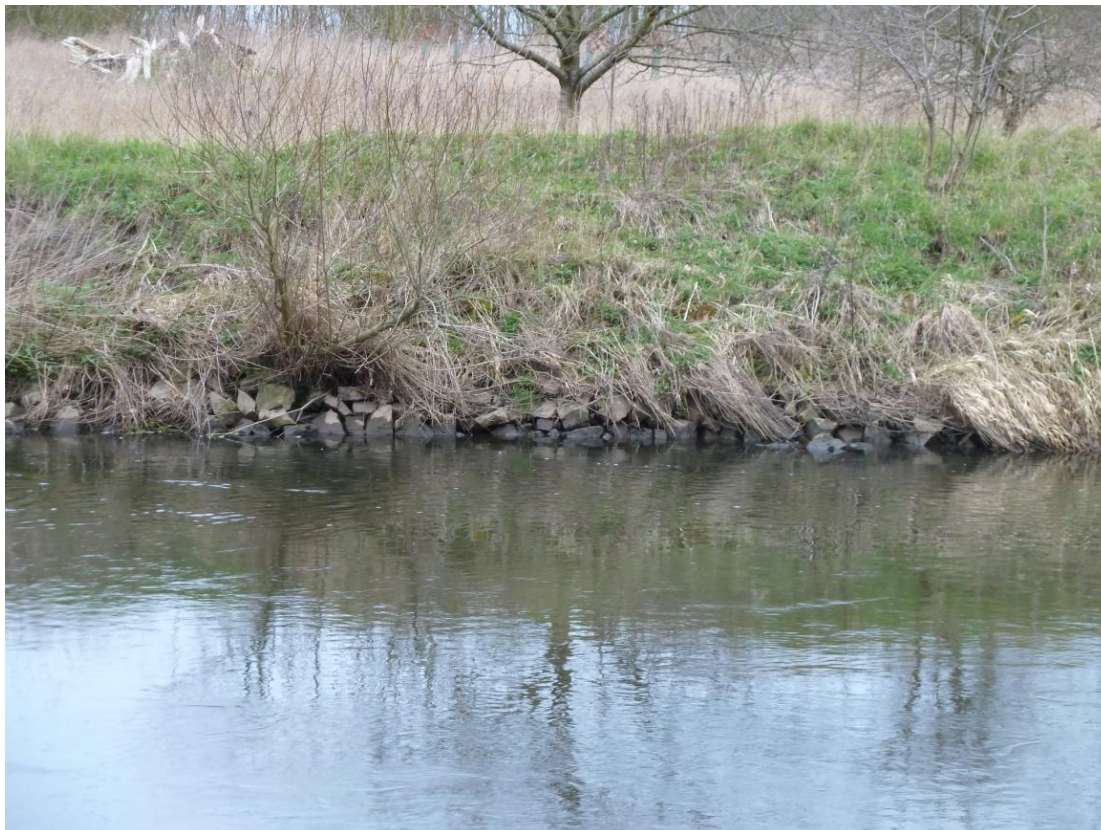
Figure 1-3: Stone pitching providing bank protection

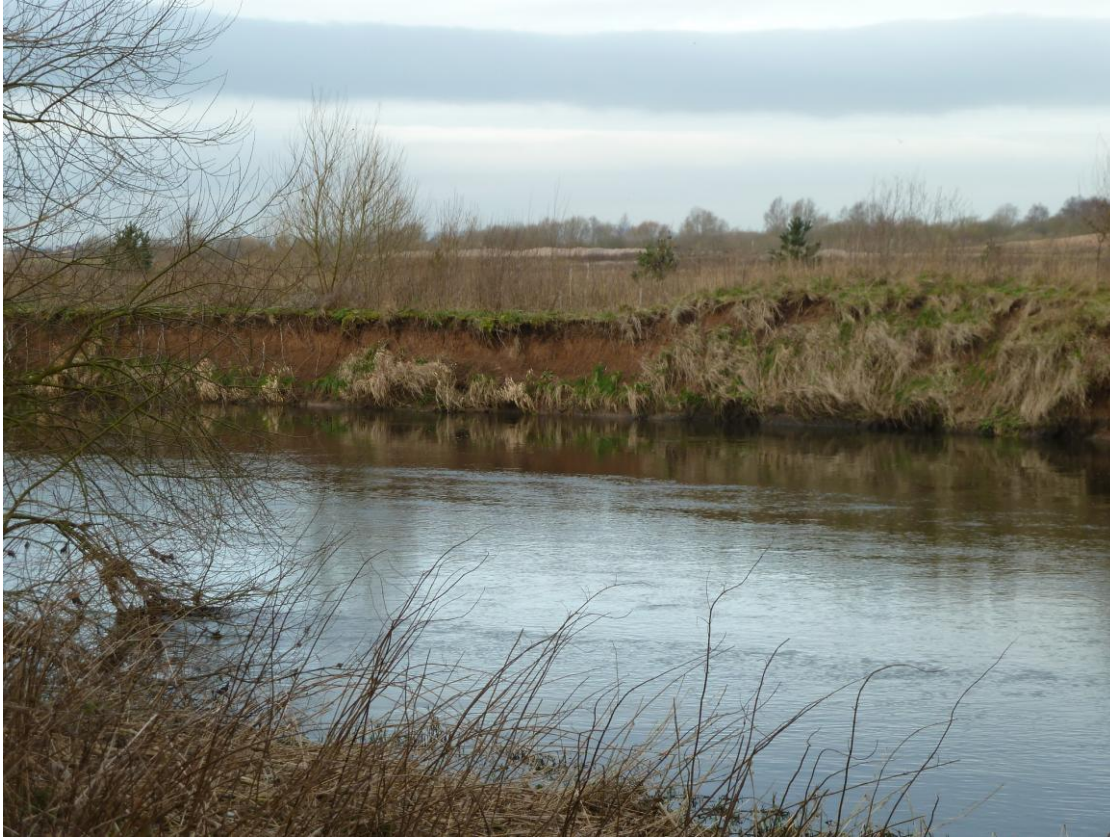
Figure 1-4: Bank erosion where stone pitching has failed

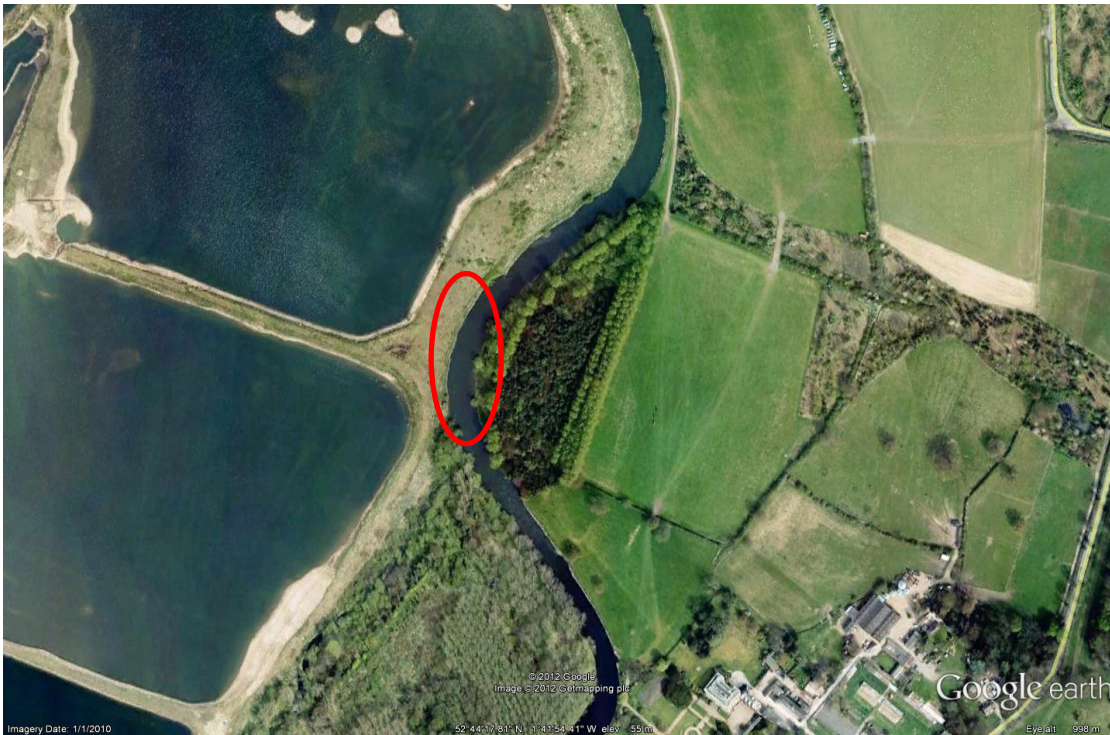
Figure 1-5: Trent aerial view of local bank erosion (Copyright Google Earth 2012, Infoterra & Bluesky 2012)

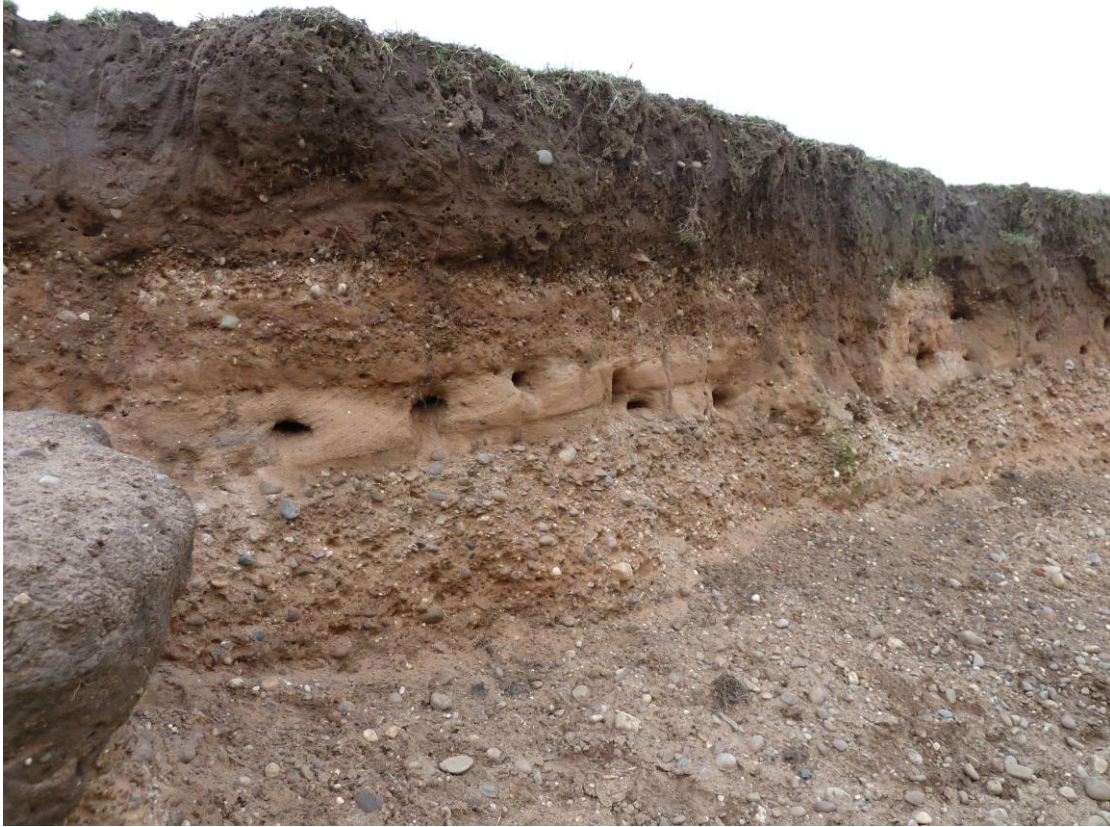
Cessation of regular dredging of the channel at Catton Estate has led to channel bed recovery in some locations where gravels are accumulating to form riffles. One such location is at Catton Hall where a significant local source of gravel (approximately 1.5m deep along 200m of bank) along the right bank has been reworked at higher flows to supply the riffle development just downstream (Figure 1-6, Figure 1-7 and Figure 1-8).

Figure 1-7: Local right bank gravel source

Just downstream of the existing island feature shown in Figure 2-2 is a significant local coarse gravel source (Figure 1-7). It is important to retain this local source given the limited upstream inputs and the recovery of the gravel bed local to the source. The gravels suggest the current channel is running through a paleo-channel and the steep sided banks are enabling entrainment of gravels into the flow regime at higher flows. This process should be encouraged and therefore it is recommended that woody species are not planted close to the bank edge as this would result in bank consolidation and stabilisation (Figure 3-5). Tree planting should be set back further into the floodplain to allow the current bank erosion processes to continue.

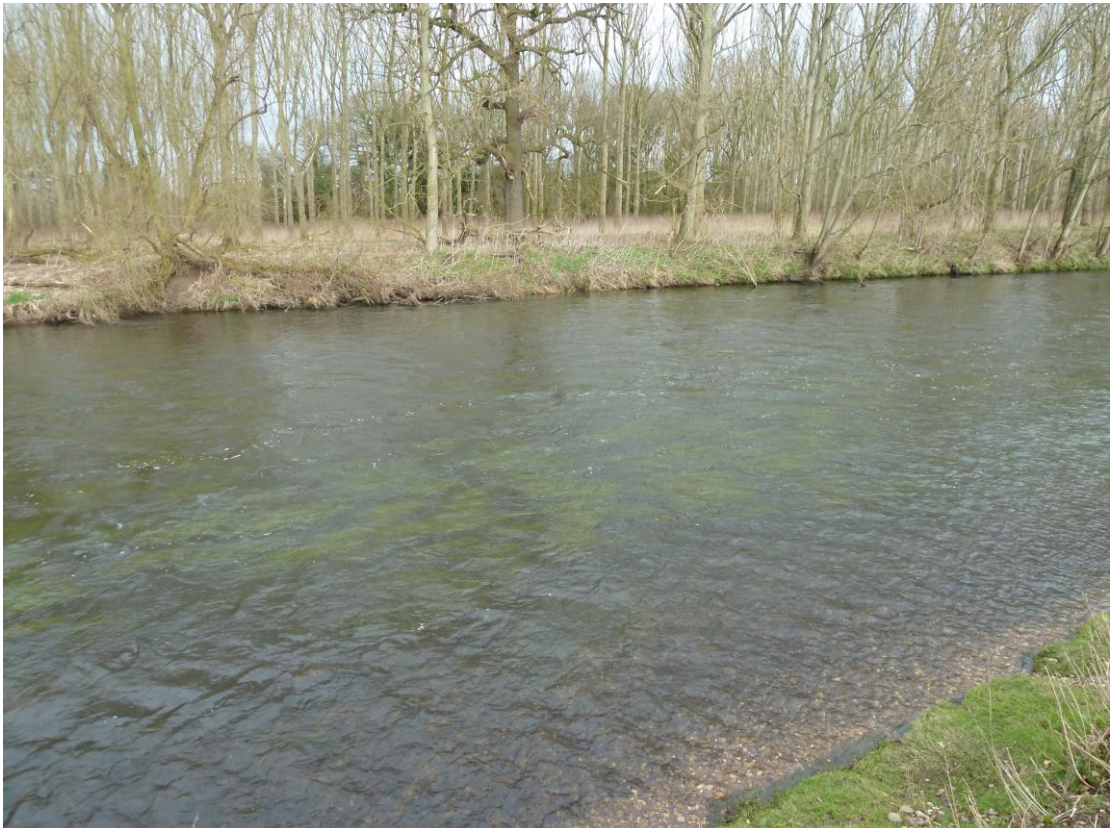
Figure 1-8: Riffle development

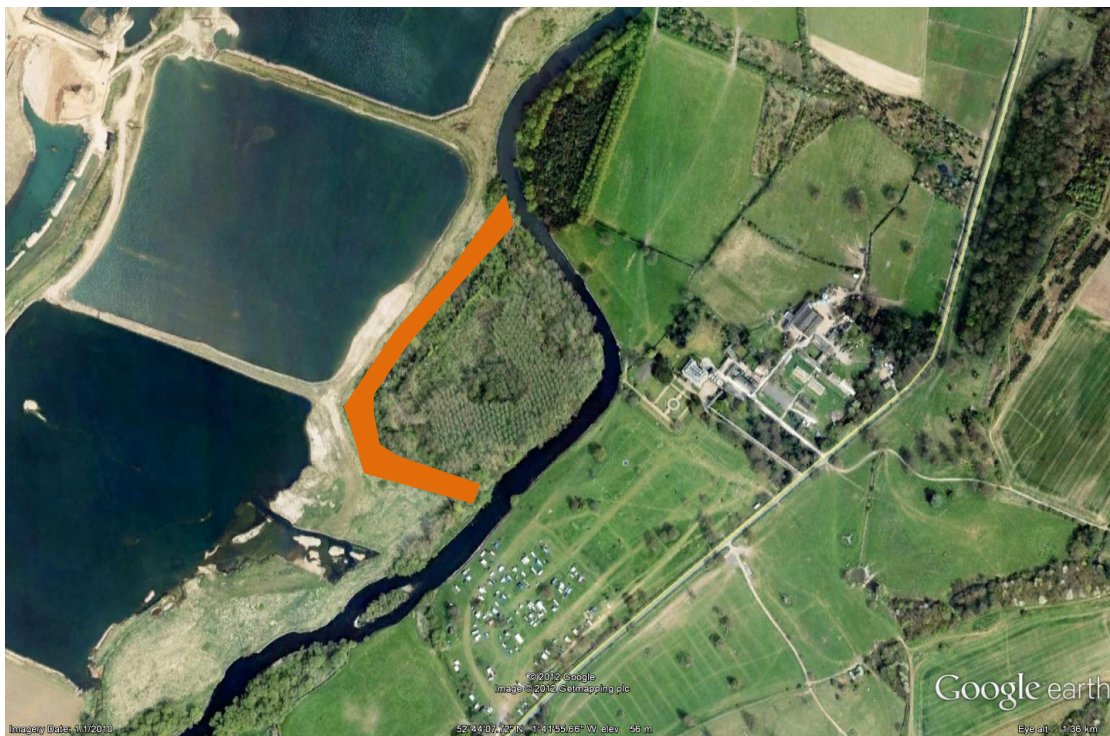
Adjacent to the Catton Hall building, over the left bank (labelled Cherry Holme on OS Mapping) there is a paleo-channel where the Trent once bifurcated, as shown below in Figure 1-9. Old maps indicate this channel was abandoned between 1955-1964, it is unclear whether this was through artificial inference (such as dredging) or through natural infilling of the left bank.

Figure 1-9: Paleo-channel adjacent to Catton Hall (Copyright Google Earth 2012, Infoterra & Bluesky 2012)

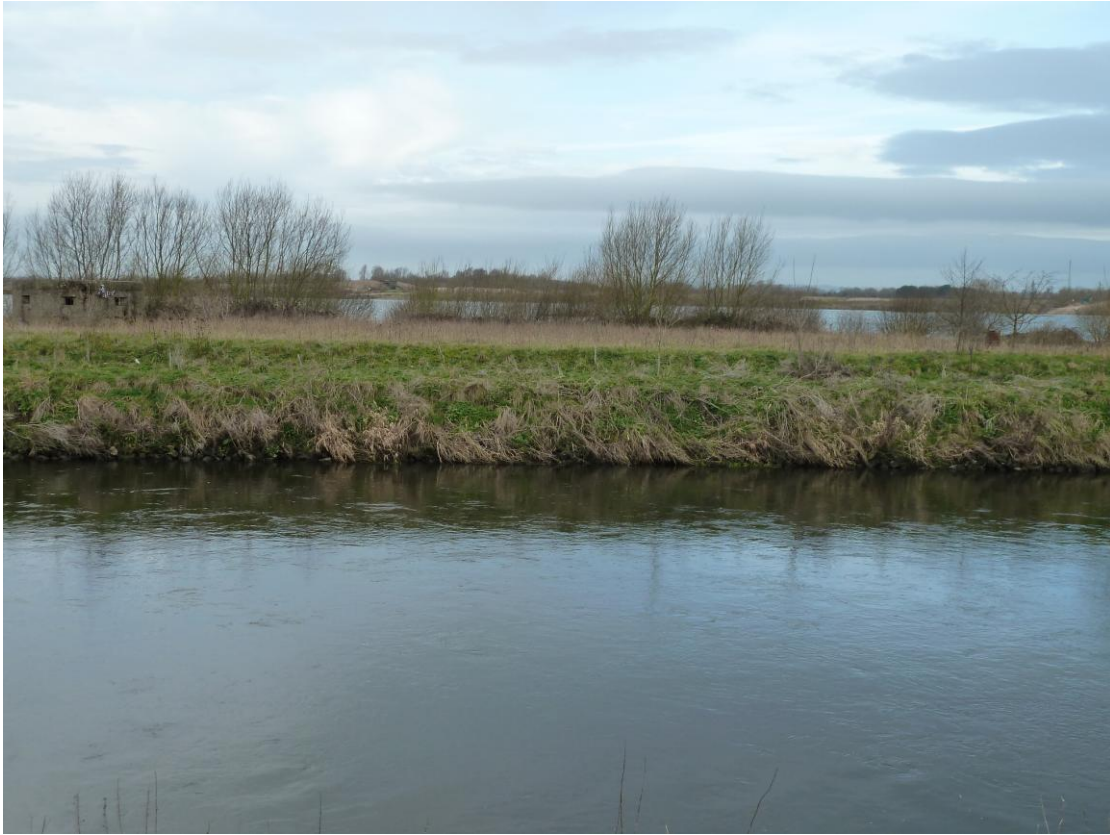
Figure 1-10: Raised bank level through deposited dredged material

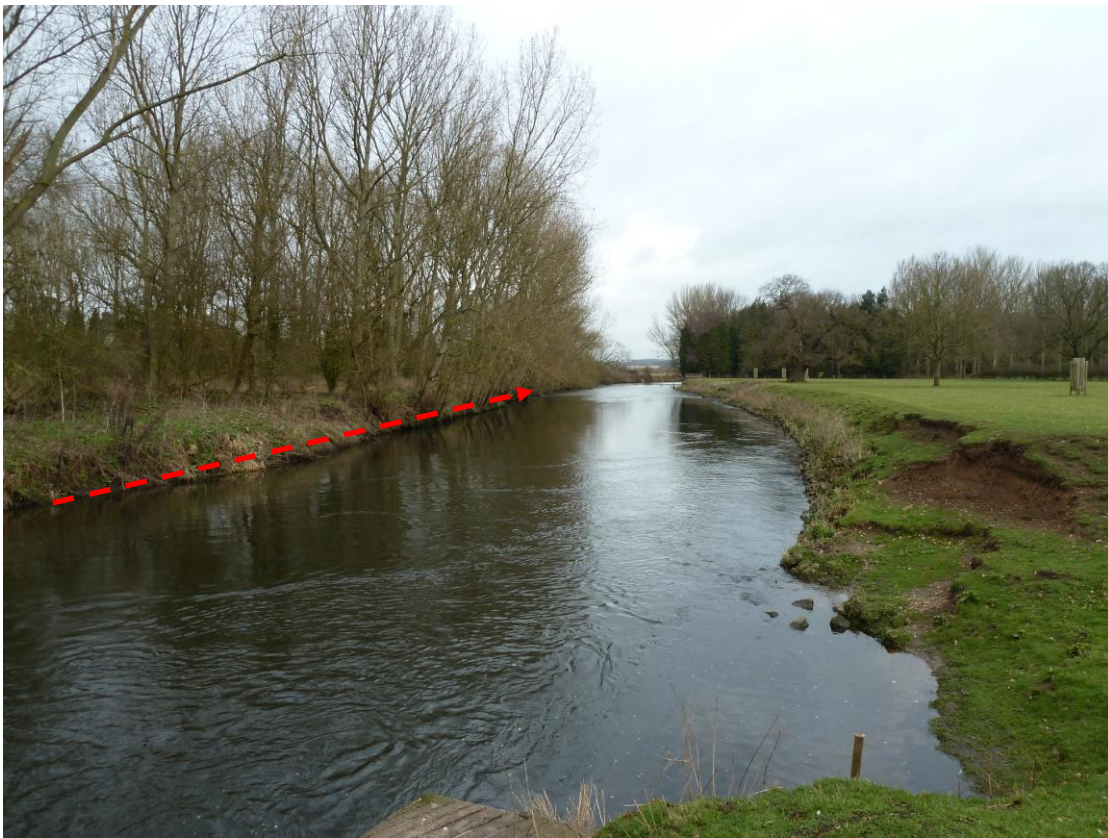
Figure 3-3: Left bank at Cherry Holme, opportunity to lower level and reconnect floodplain

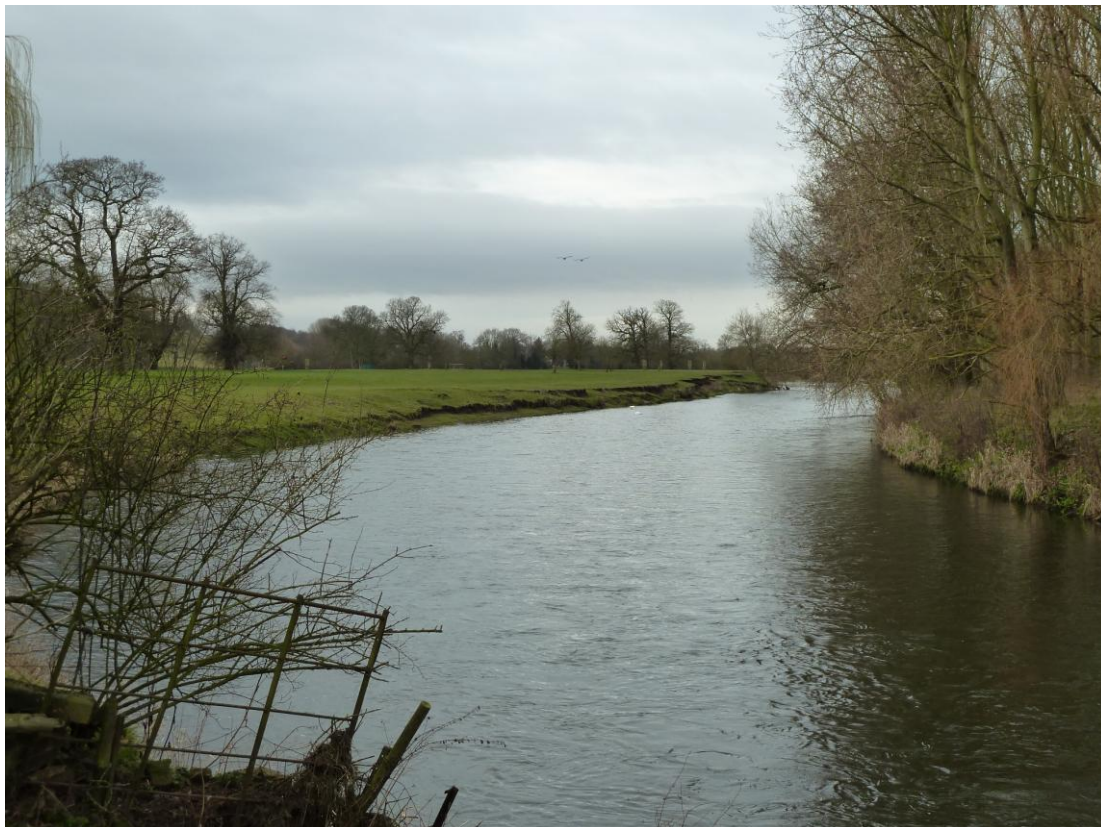
Figure 3-7: Looking upstream at stepped bank profile at Catton Hall Estate

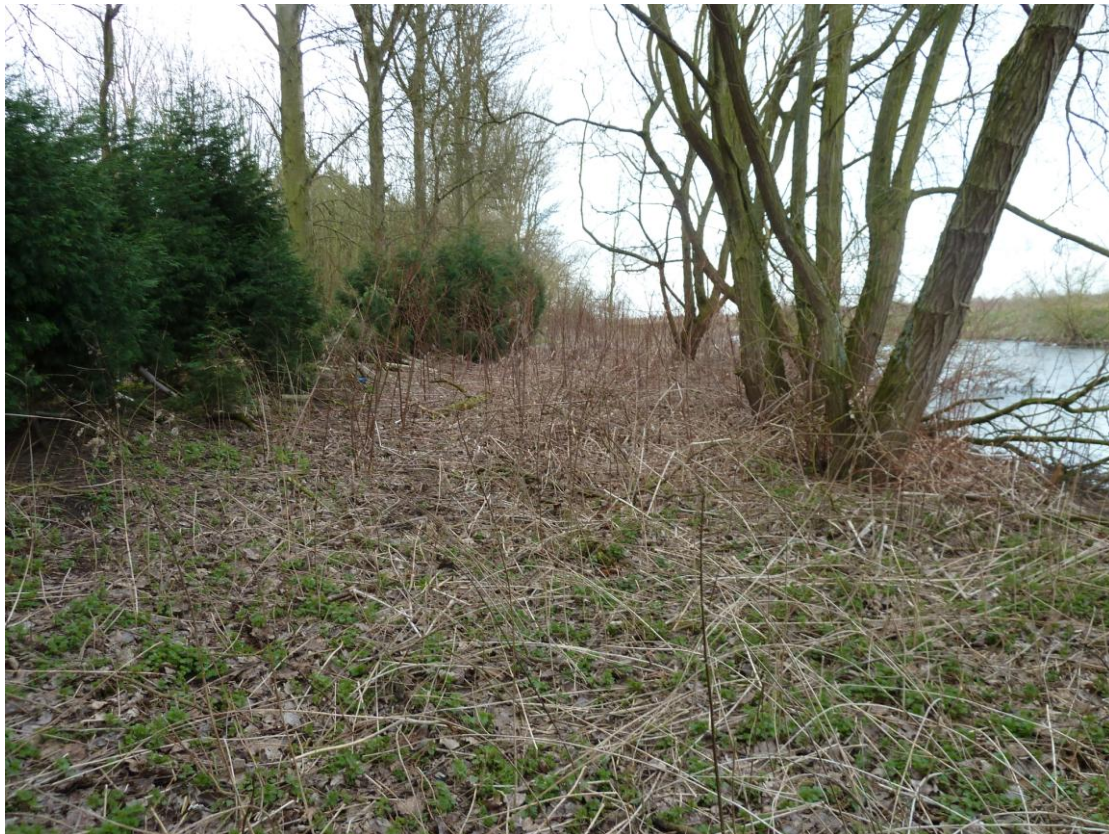
Figure 3-9: Existing point bar where regrading is suggested

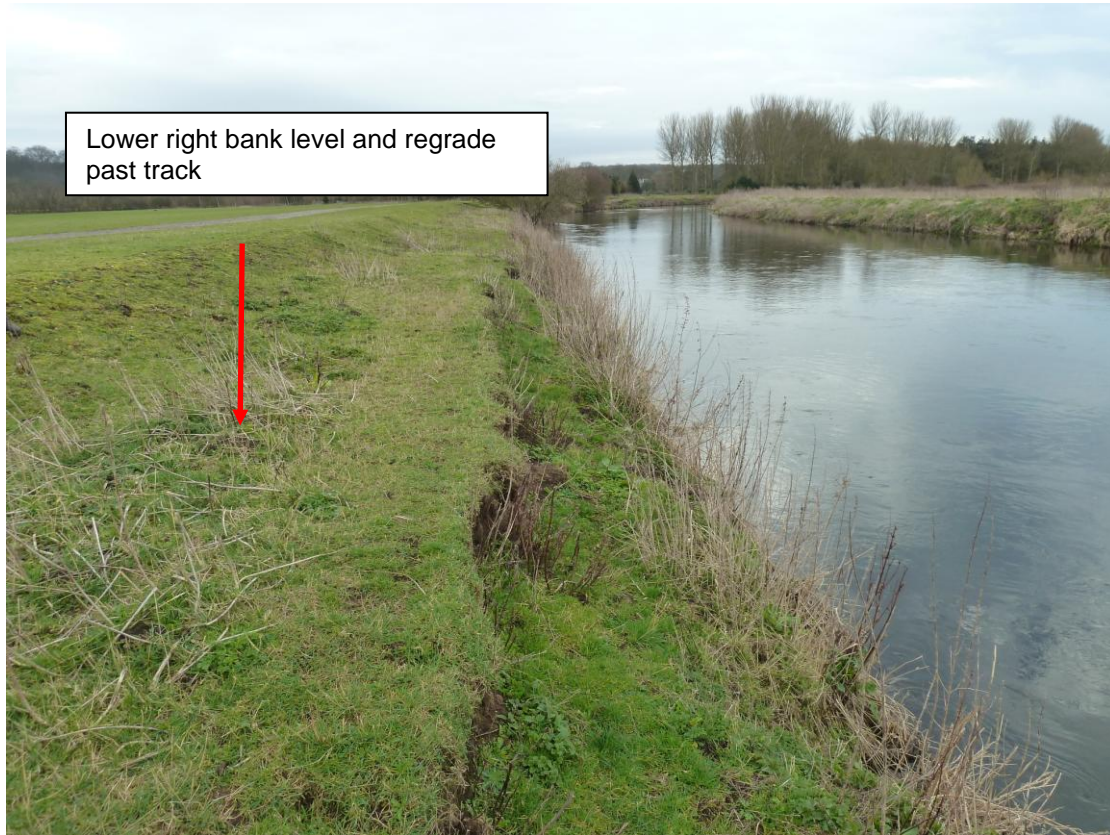
Figure 3-11: Floodplain reconnection and bank regrading

The proposed bank regrading of the right bank, downstream of the meander, should be undertaken as shown in Figure 3-11 and Figure 3-13 below. This would involve regrading the bank past the existing track into the floodplain (dropping immediate bankside levels by 1-2m). Therefore, the track would need to be moved if this is to be undertaken. It is not recommended to regrade the right bank at the outer bank of the meander bend, as this is working against the natural erosion pattern at this location.

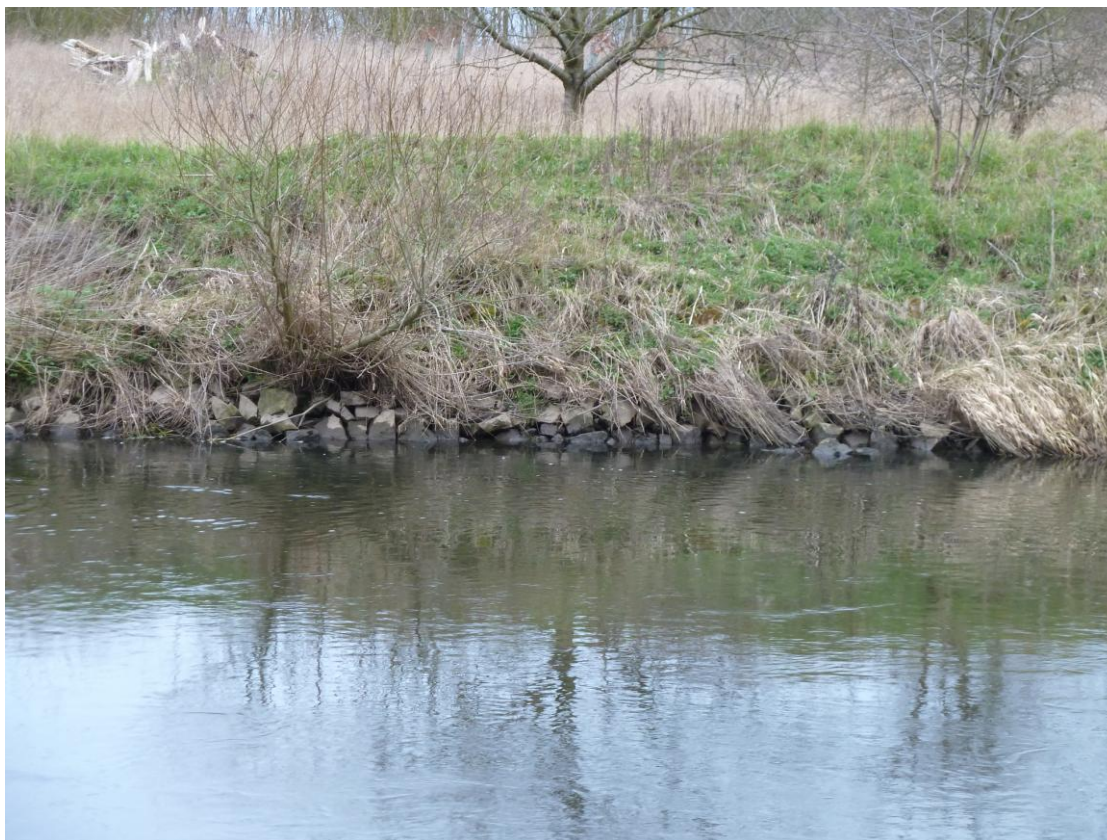
This section of the reach is experiencing bank slumping in response to the over-deepened channel. Stone pitching (rip rap) is protecting the toe of the left and right banks in numerous locations along this reach (Figure 3-12). There is potential to remove this stone pitching to allow a more natural bank profile to develop, particularly on the outer bank of the meander which currently exhibits a stepped profile rather than a steep faced bank that would normally occur under unprotected conditions. Significant lateral migration could be managed through bankside planting with woody species.

Figure 3-12: Stone pitching that could be removed on both banks

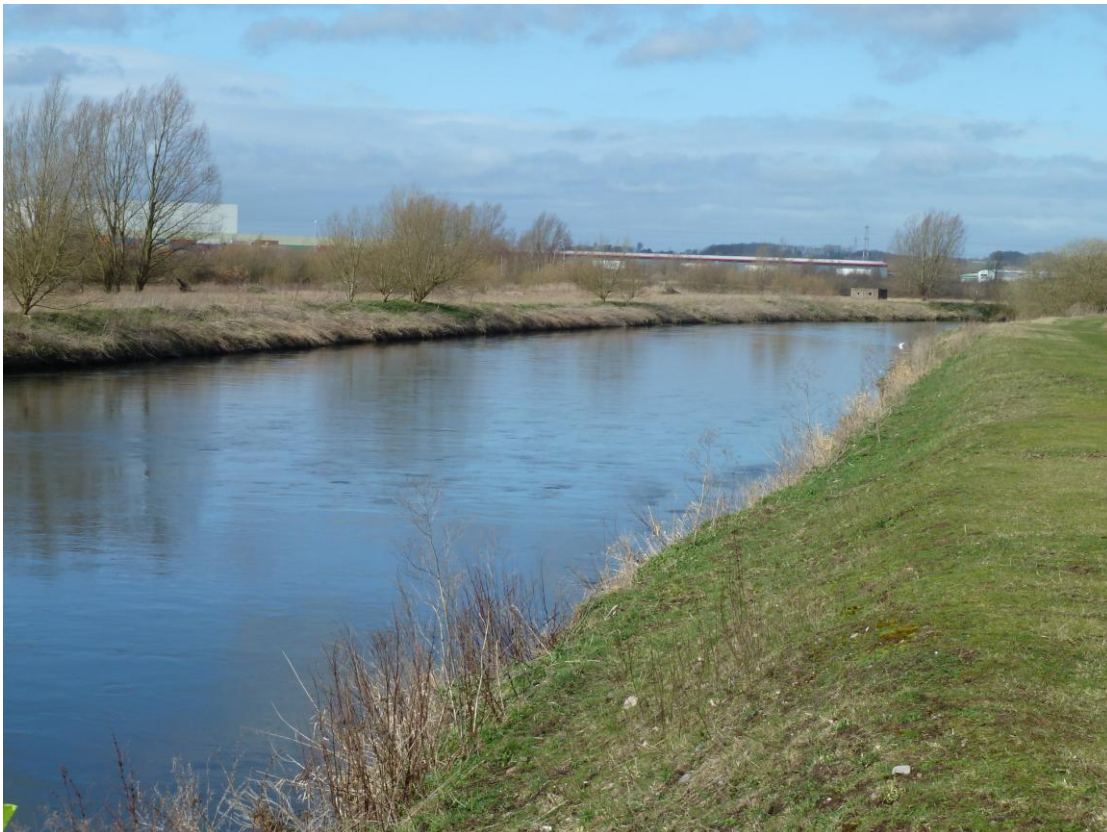
Figure 3-17: Uniform, over-deepened channel

There is also an opportunity to undertake works on the extended point bar downstream. This would relieve the erosion pressure on the left bank where there is only a thin buffer strip between the main Trent channel and the gravel lakes. The proposed works are regrading of the point bar to improve connectivity and introducing a chute channel similar to that proposed at Ryelands Nook, which would leave a linear island feature (Figure 3-17). It is also recommended that bankside woody species planting is undertaken over the left bank to consolidate the thin embankment between the channel and the gravel lakes.
