Fish Live in Trees Too!

River Rehabilitation and Large Woody Debris

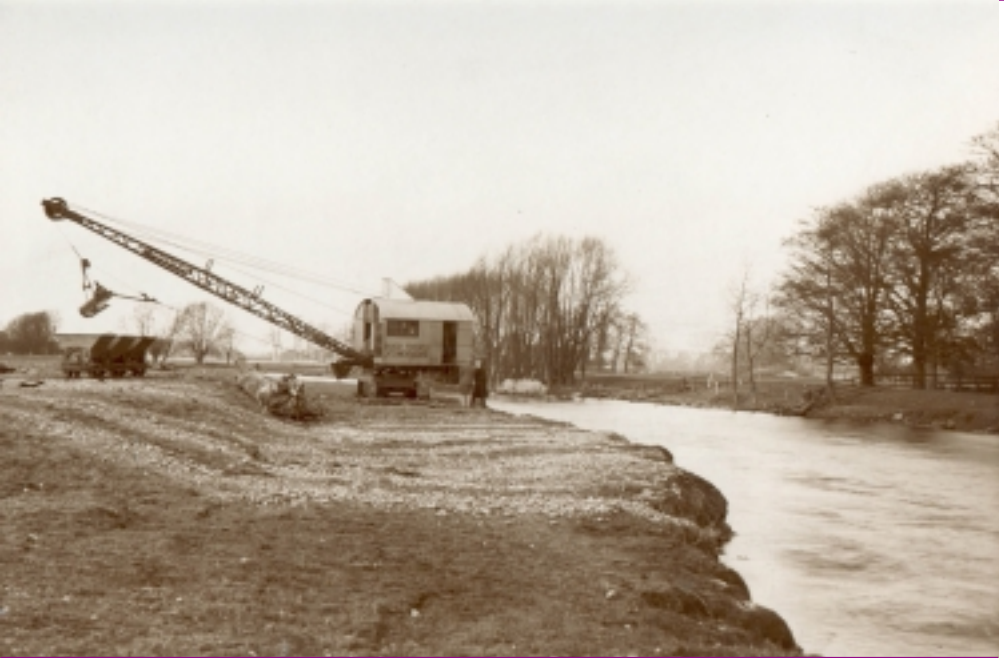
Gutted. The Trent River Catchment Board carrying out routine maintenance along the River Dove in the 1940s using a drag line. Notice the LWD removal and the creation of a trapezoidal channel.

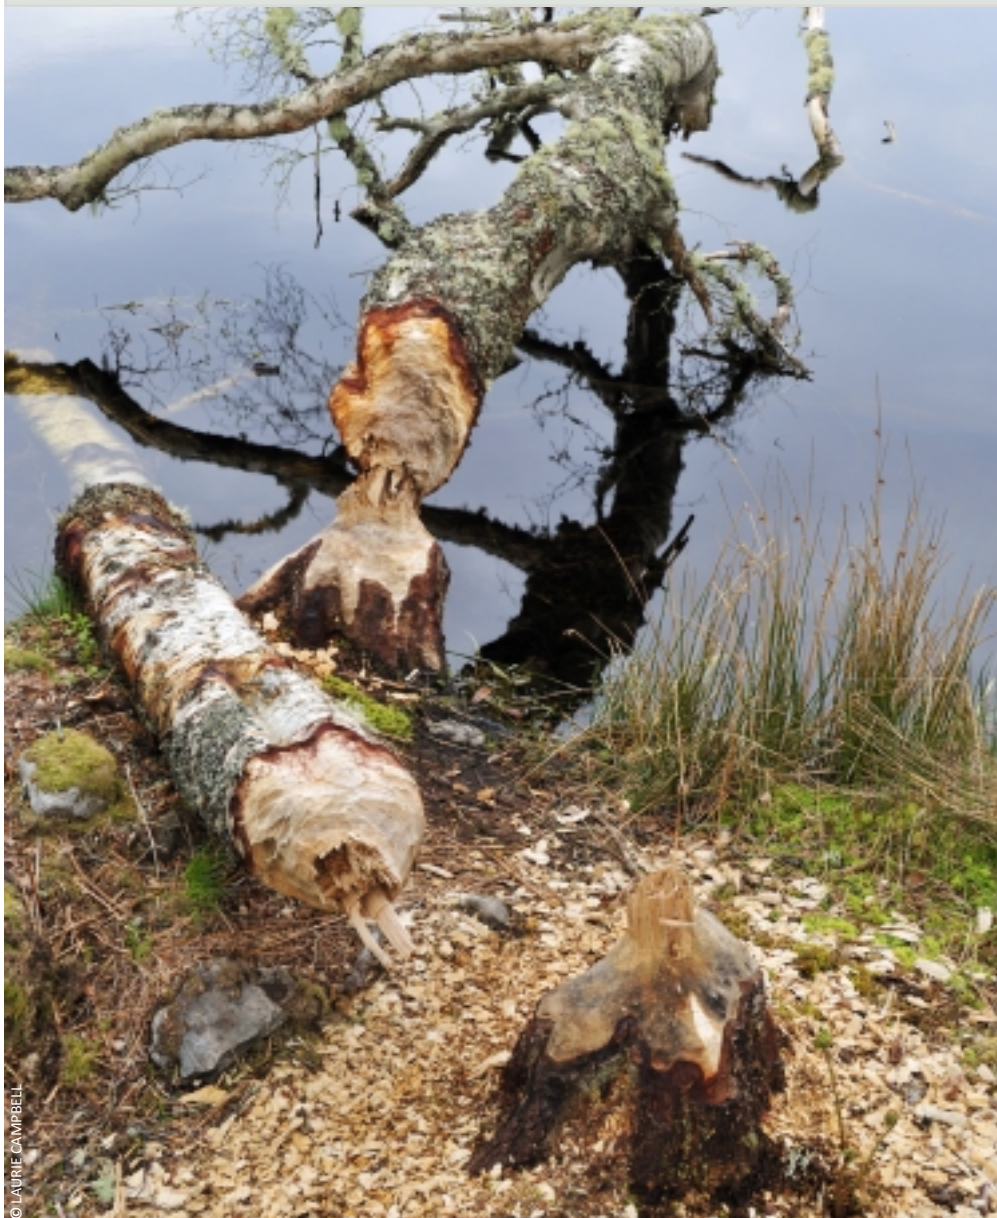
The Scotch Brook, Staffordshire. As unmanaged willows shed large limbs and collapse across streams, channel complexity increases and, correspondingly, habitat niches are generated for an increased range of species.

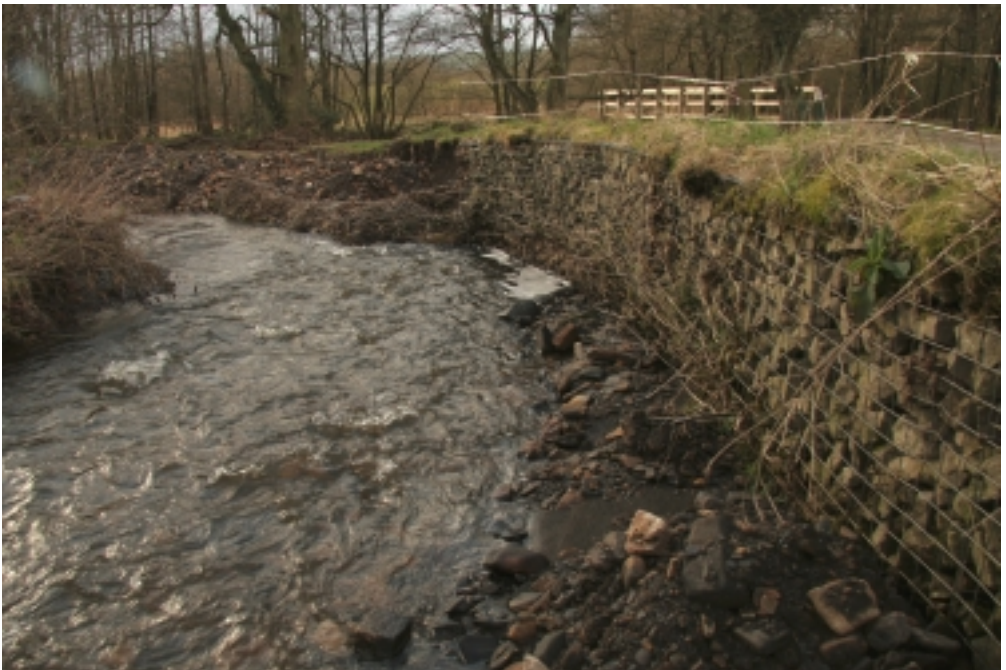
View of the collapsing gabions in 2008

Severn Trent Water owns and manages the Tittesworth Water estate. In the 1980s a section of the River Churnet's banks was reinforced with gabions (steel baskets filled with rock) to help protect a nearby road and footpath. The energy and power of the River Churnet soon undermined the gabions. Staffordshire Wildlife Trust offered to trial a more sustainable option: the use of an Engineered Log Jam and bank support using living willow tree trunks.

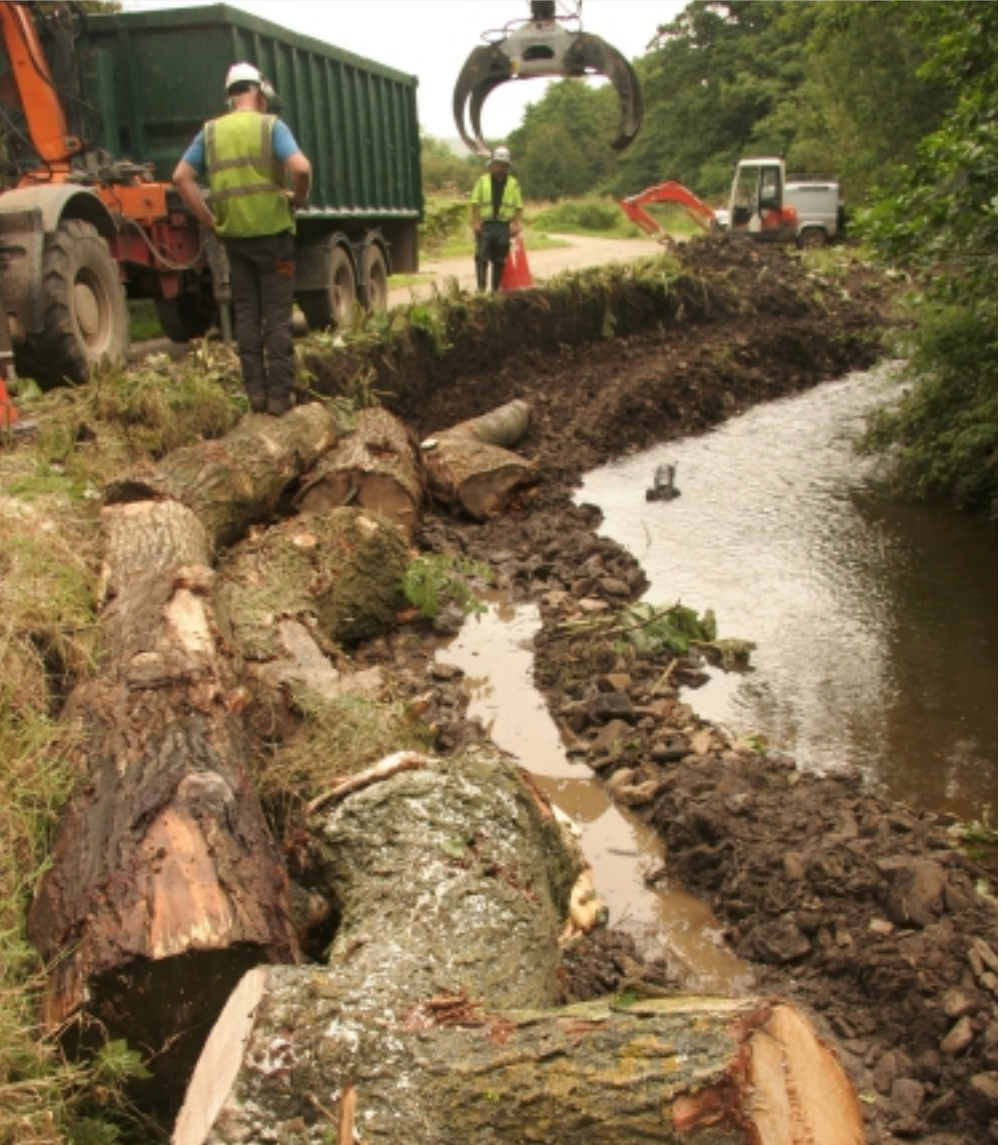
August 2009. The gabion baskets were removed and replaced with living, sprouting willow trunks.

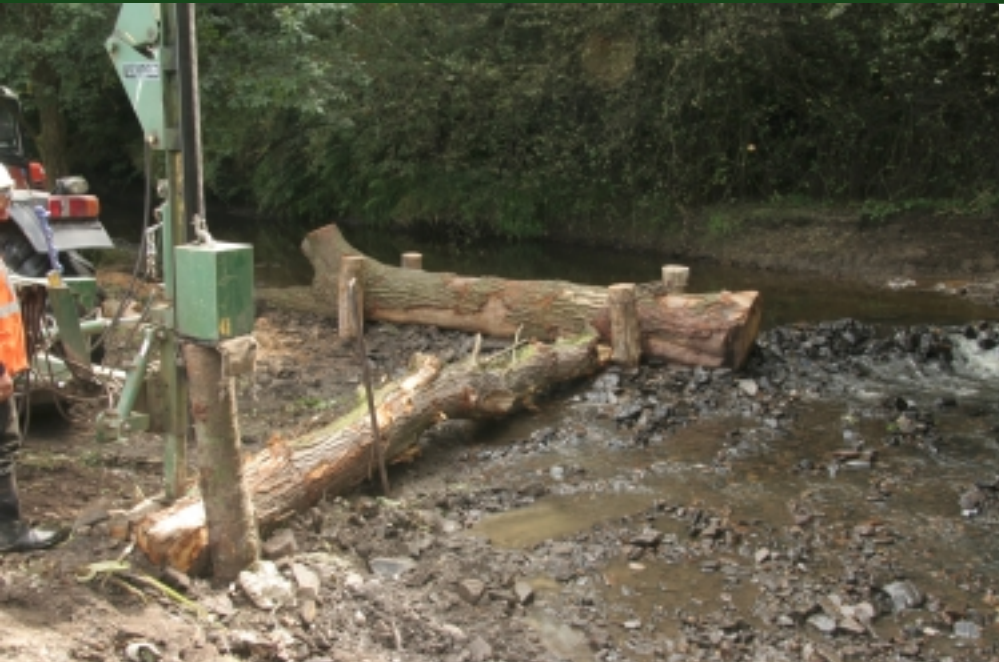
The 'Key Piece' of the ELJ was a 5 tonne oak tree trunk. This was 'keyed' into river bed and supported with oak posts driven deep into the substrate. Further strength was created by adding a 'T piece'.

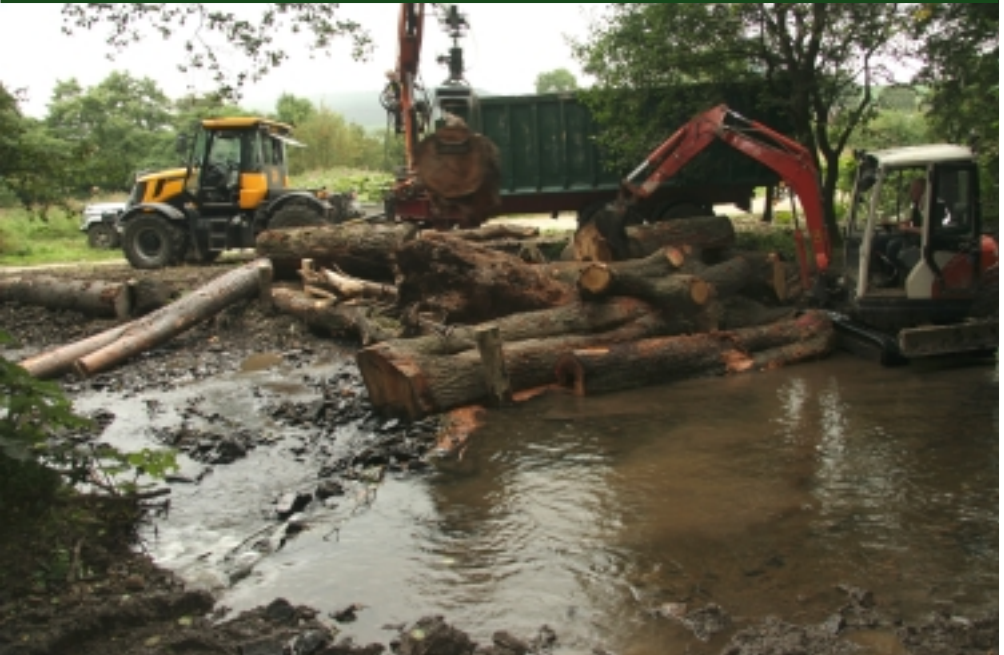
A further 22 tonnes of trunks and root plates were used to construct the ELJ.

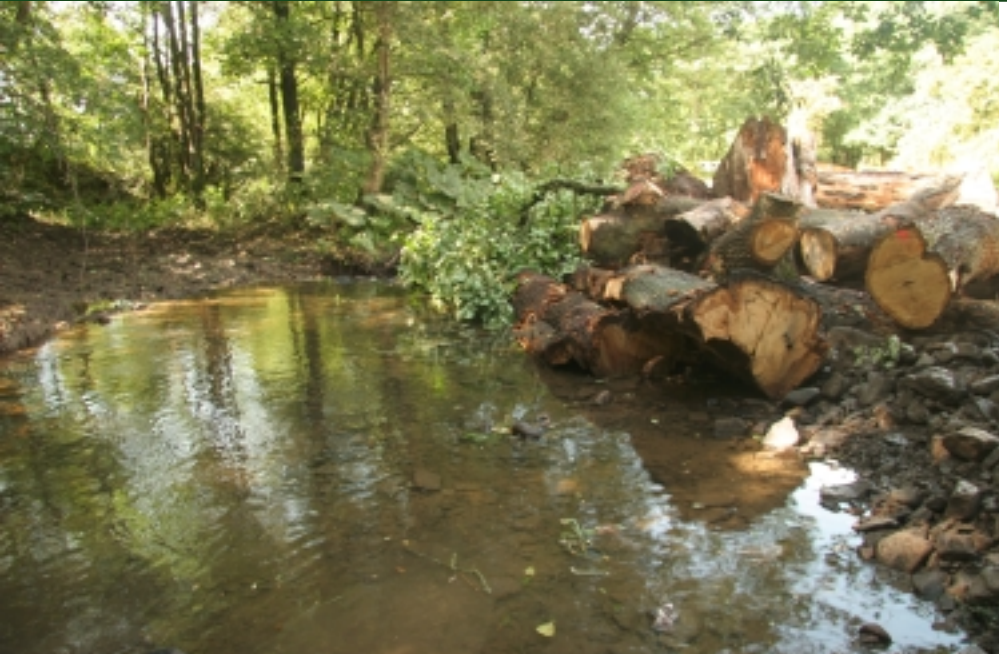
View of the completed ELJ and the entrance to an old side channel.

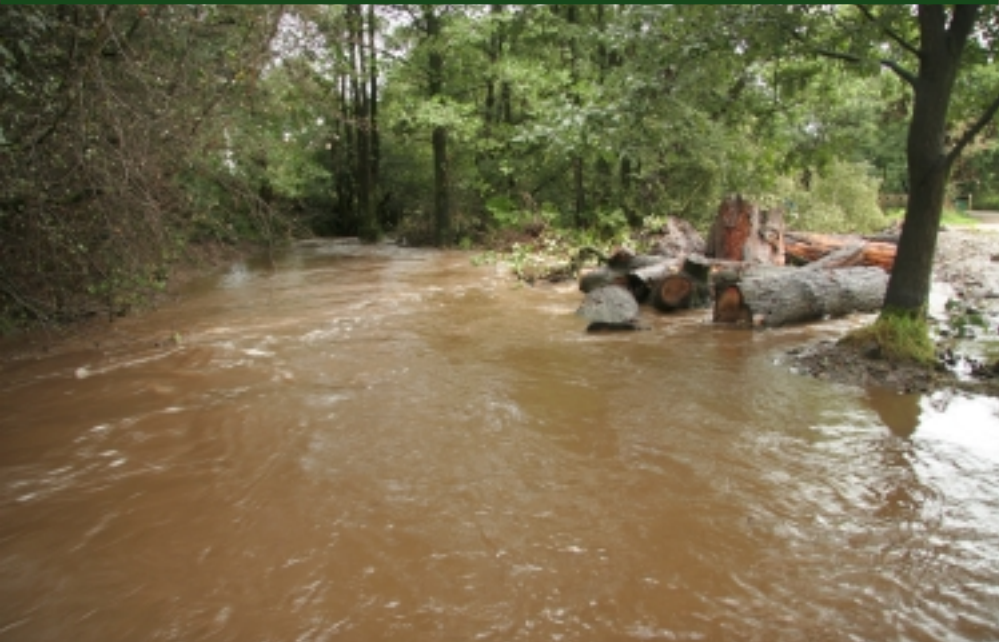
September 2009. It works! Just two weeks after the ELJ had been completed, a late summer storm resulted in spate conditions. The position of the ELJ re-activated an old channel. It is estimated that, at the peak, a third of the River Churnet's flow was diverted into this former channel.

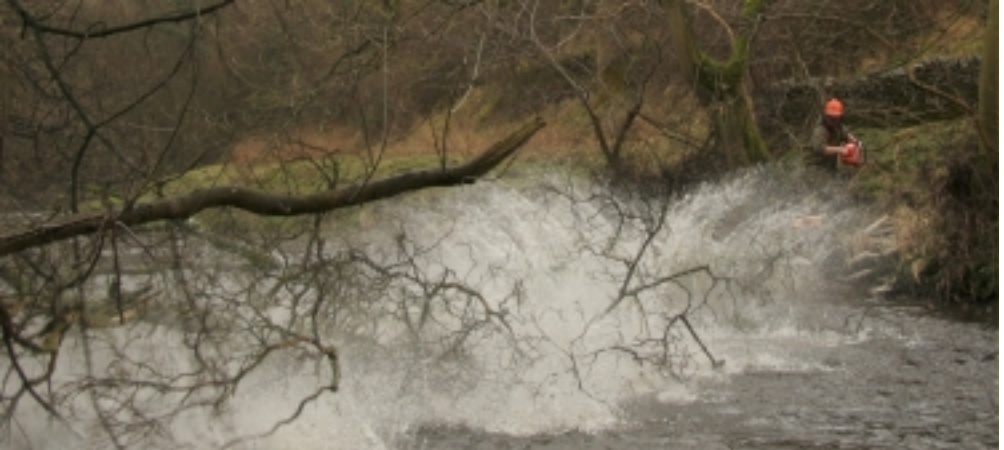
Chop & Drop. A sycamore becomes LWD in the Upper Dove. Introduced material needs to be longer than the channel width.

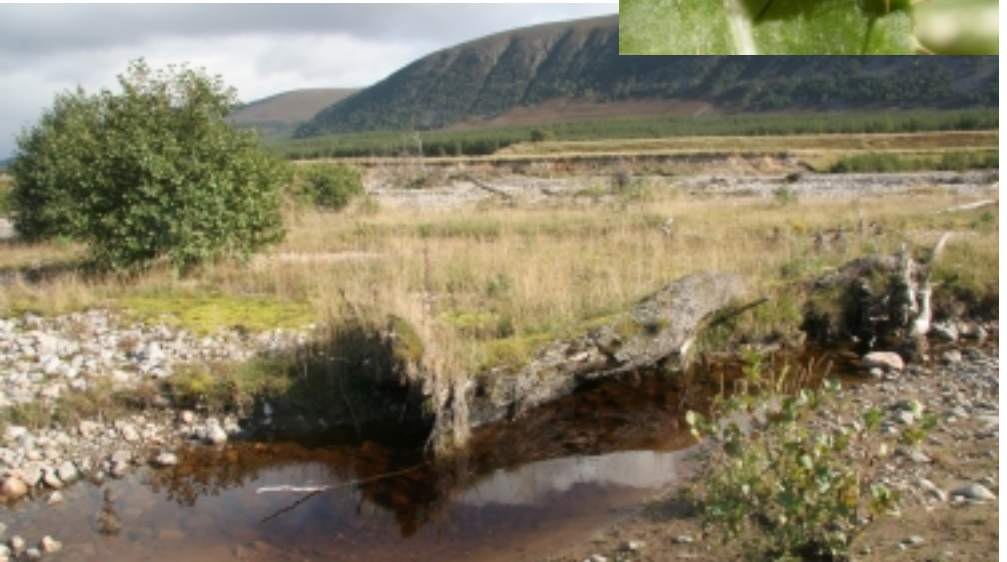
LWD and sprouting driftwood often becomes embedded in the river's substrate. This results in the development of additional features such as ephemeral pools, germination zones and islands.

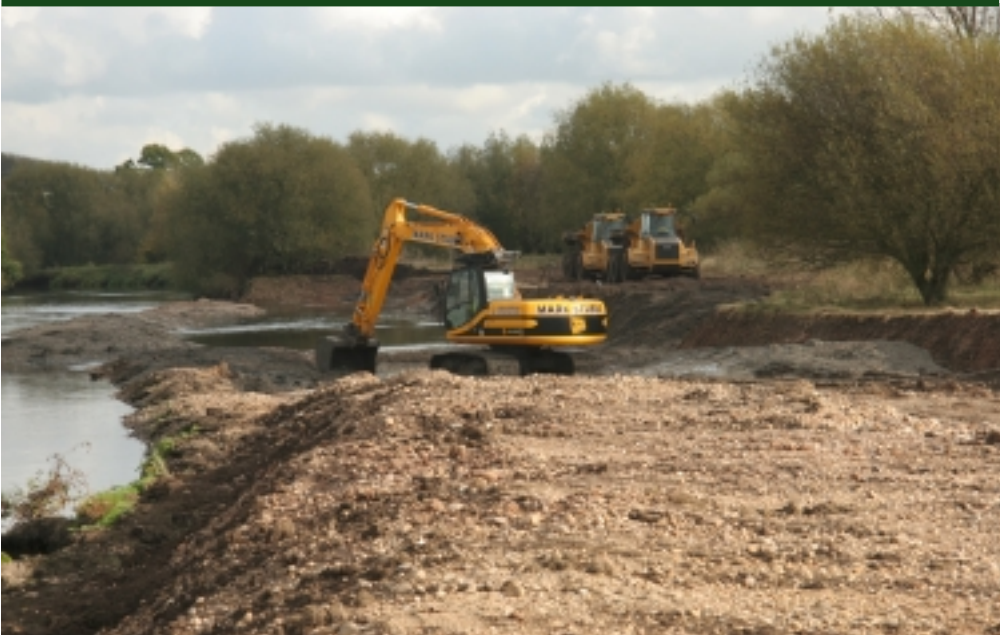
43,000 cubic metres of soil were removed during the channel widening scheme and deposited in the two lakes at the site to create substrate and shallows for new reedbeds. Gravels were retained and used to create river islands and mid-channel sediment bars.

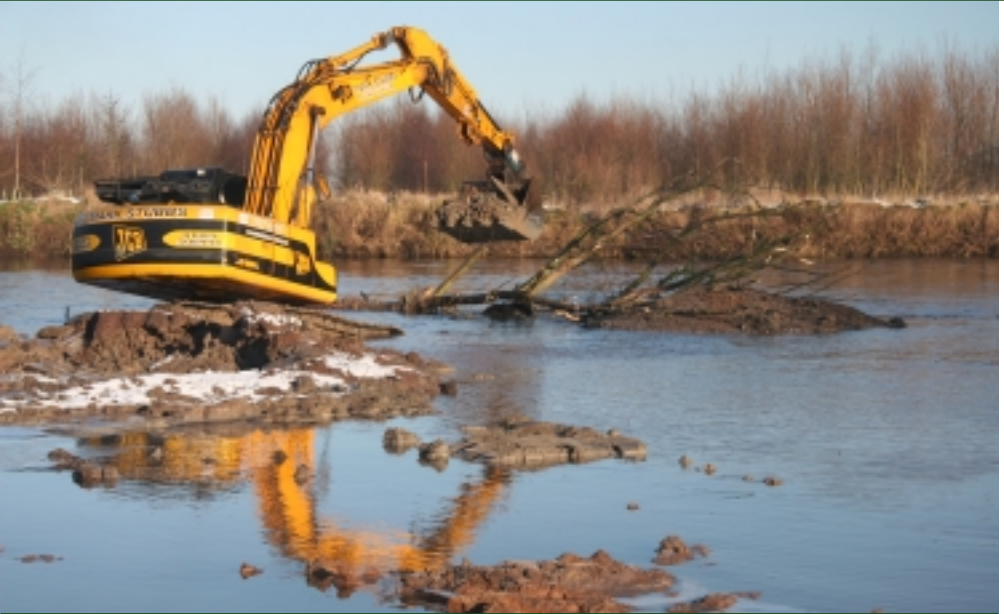
Several new willow river islands were created within the widened channel.
(i) a scrape was excavated in the river substrate, (ii) live willow trees were placed into the scrape with their root plates facing in an upstream position, (iii) clay and gravels were placed on top of the LWD, (iv) ...and the island is left to develop and strengthen naturally as the willow grows adventitious roots into the river bed.

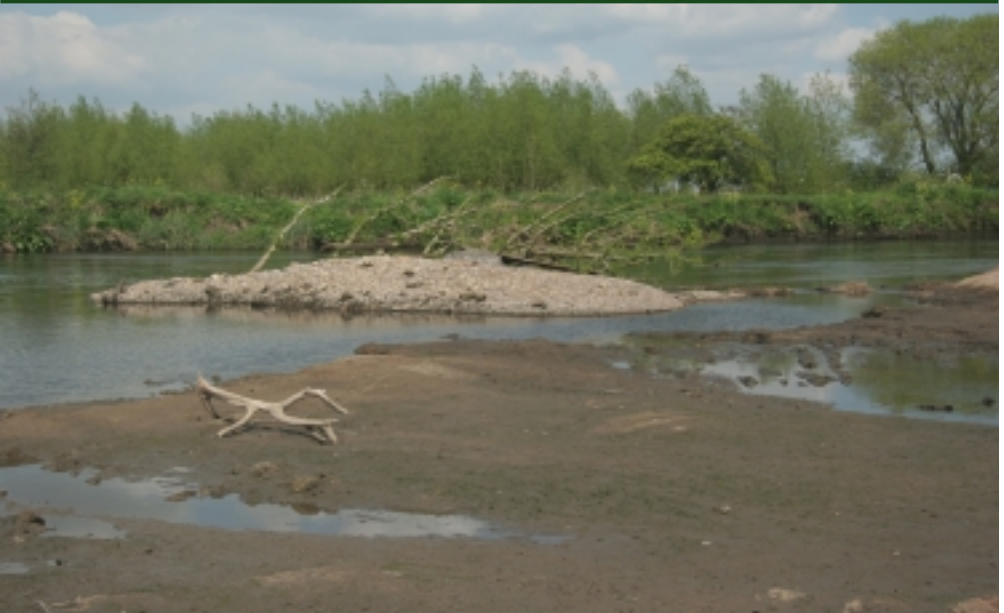
May 2010. A view of one of the newly created river islands - note the leaves.

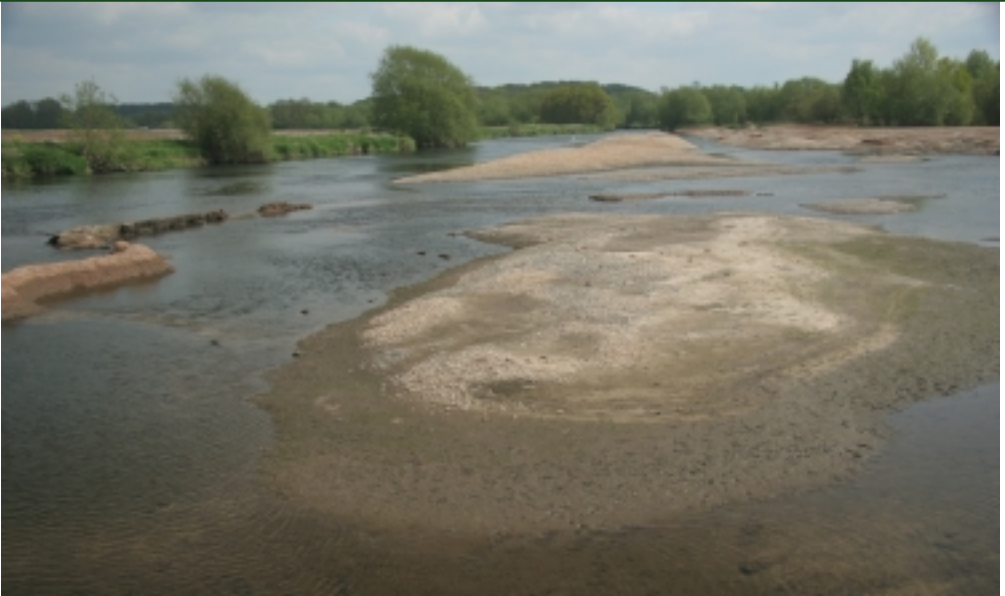
May 2010. A view of the completed river widening scheme with islands, sediment bars, backwaters and lagoons.

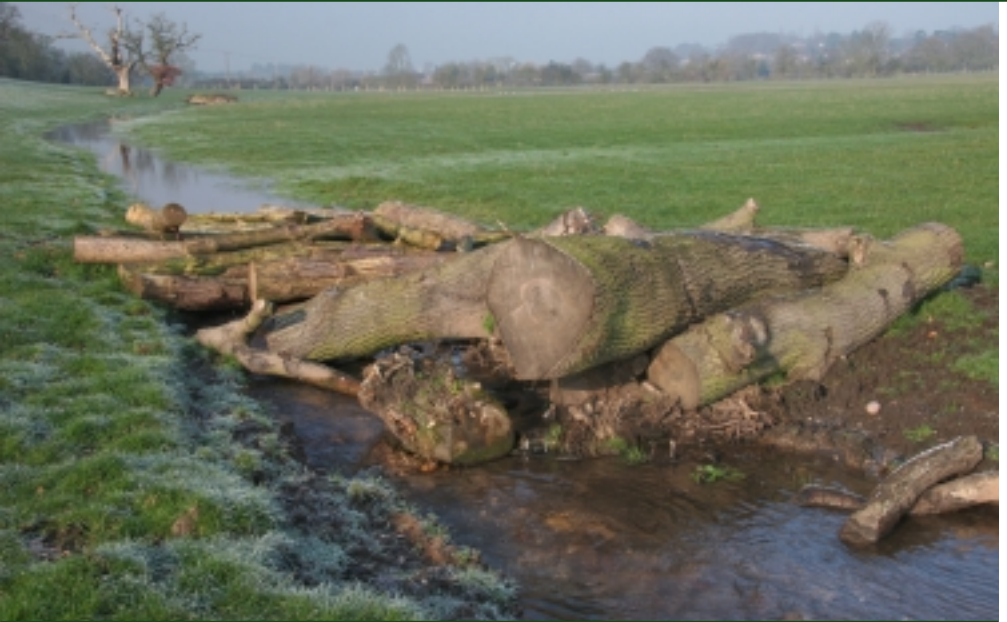
One of the constructed log jams along the newly diverted brook.

Two streams, which had historically crossed the site, were diverted back across the floodplain. Water in these streams has been impeded using log jams as 'leaky barriers'. These have provided habitat for foraging lapwing chicks, as well as cover and full access for aquatic species along the length of the watercourse.

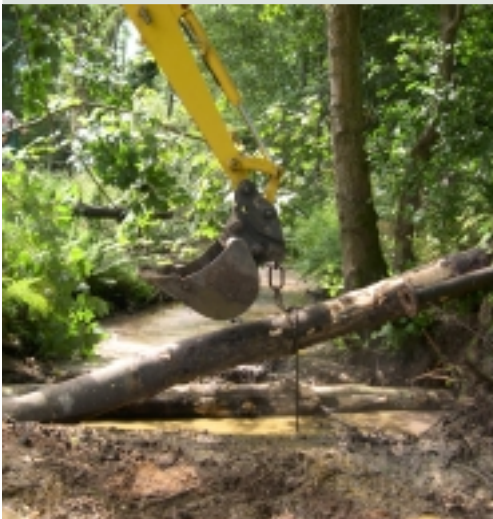
LWD was installed at a number of sites to raise riverbed levels and create additional habitats in the channel.

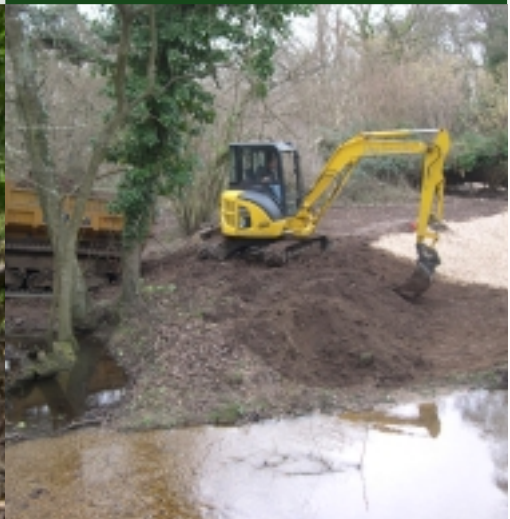
A new channel was excavated and river re-profiling carried out.

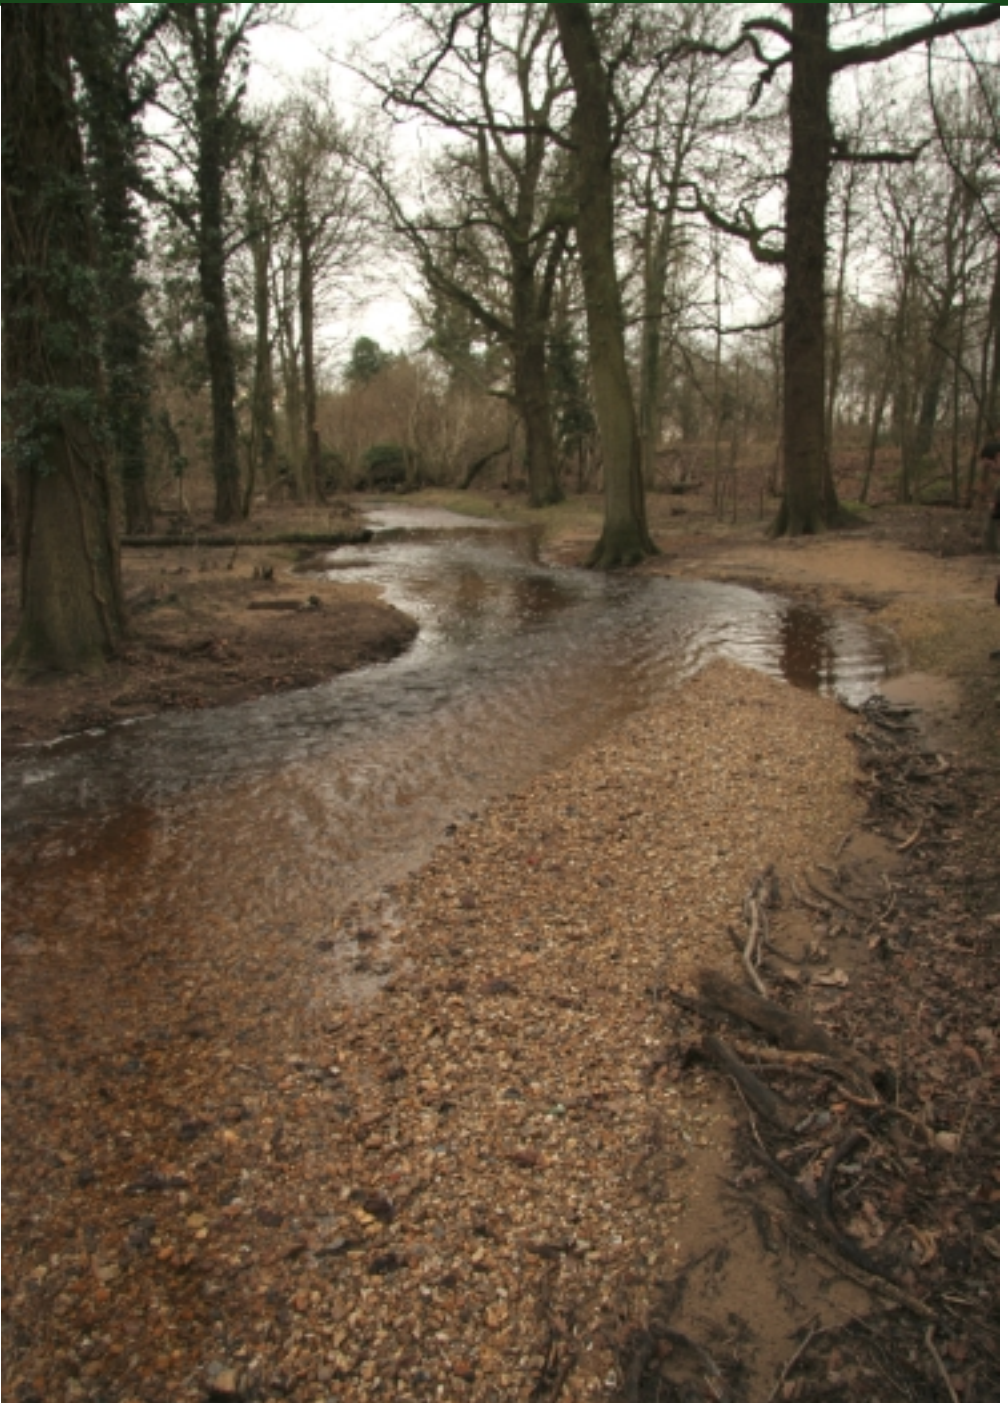
January 2008, three years on. The restoration work has been very successful. There is now a much better link between Dockens Water and its floodplain.

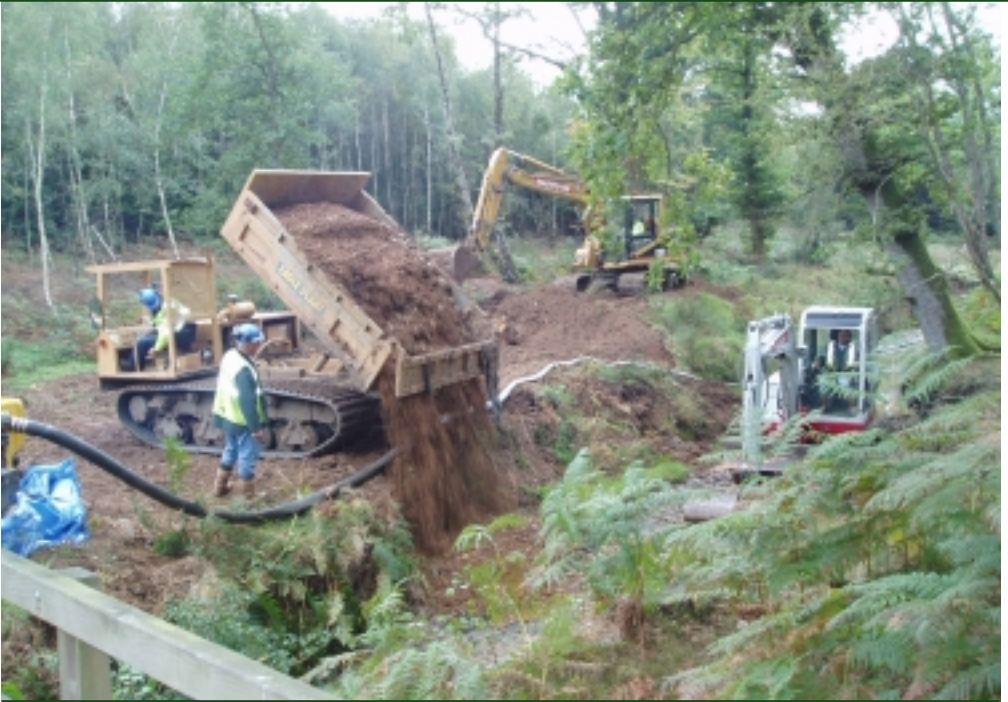
Life3 scheme at Highland Water to raise bed levels.
