River Trent at the Catton Hall Estate – Hydromorphic Audit and Appraisal

Final Report

August 2012

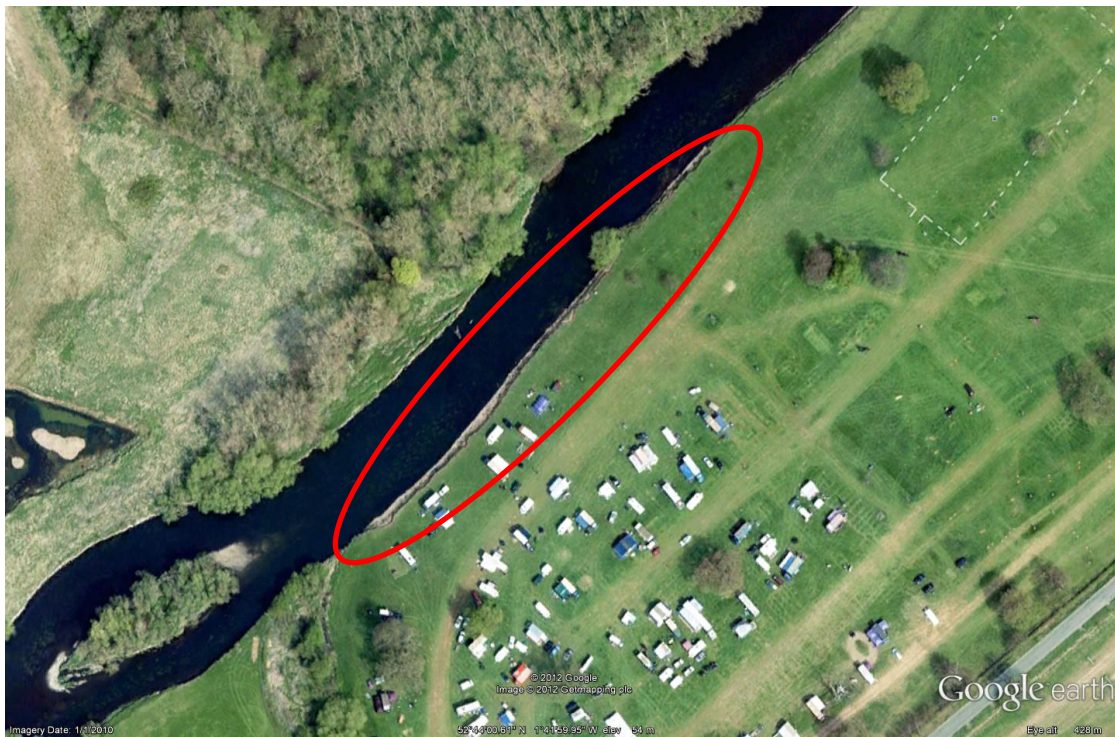
Figure 1-6: Trent aerial view - right bank gravel source (Copyright Google Earth 2012, Infoterra & Bluesky 2012)

Cessation of regular dredging of the channel at Catton Estate has led to channel bed recovery in some locations where gravels are accumulating to form riffles. One such location is at Catton Hall where a significant local source of gravel (approximately 1.5m deep along 200m of bank) along the right bank has been reworked at higher flows to supply the riffle development just downstream (Figure 1-6, Figure 1-7 and Figure 1-8).

Just downstream of the existing island feature shown in Figure 2-2 is a significant local coarse gravel source (Figure 1-7). It is important to retain this local source given the limited upstream inputs and the recovery of the gravel bed local to the source. The gravels suggest the current channel is running through a paleo-channel and the steep sided banks are enabling entrainment of gravels into the flow regime at higher flows. This process should be encouraged and therefore it is recommended that woody species are not planted close to the bank edge as this would result in bank consolidation and stabilisation (Figure 3-5). Tree planting should be set back further into the floodplain to allow the current bank erosion processes to continue.

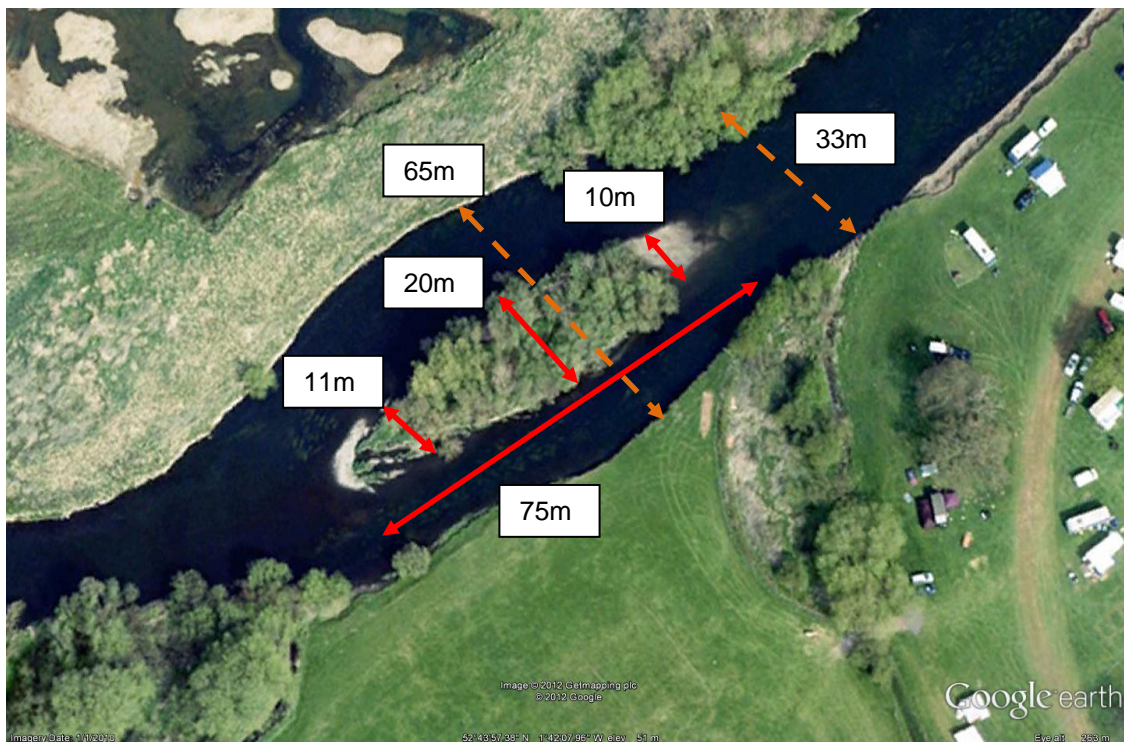
Figure 2-1: Island analogue information (Copyright Google Earth 2012, Infoterra & Bluesky 2012)

At the island within the study reach, there is a lateral response to the feature with associated channel widening that has increased the channel width by approximately 50%. Therefore, introduction of these features through the Catton reach will initiate some channel widening, however, as discussed further in section 3, this could be managed through associated tree planting to provide a buffer to widespread lateral migration. This is demonstrated below in Figure 2-1 and Figure 2-2, with indicative dimensions which have been utilised in the indicative geomorphological modelling discussed in section 3. This data is used to predict the channel response if these features were installed based on the aspirational plan in Appendix A.

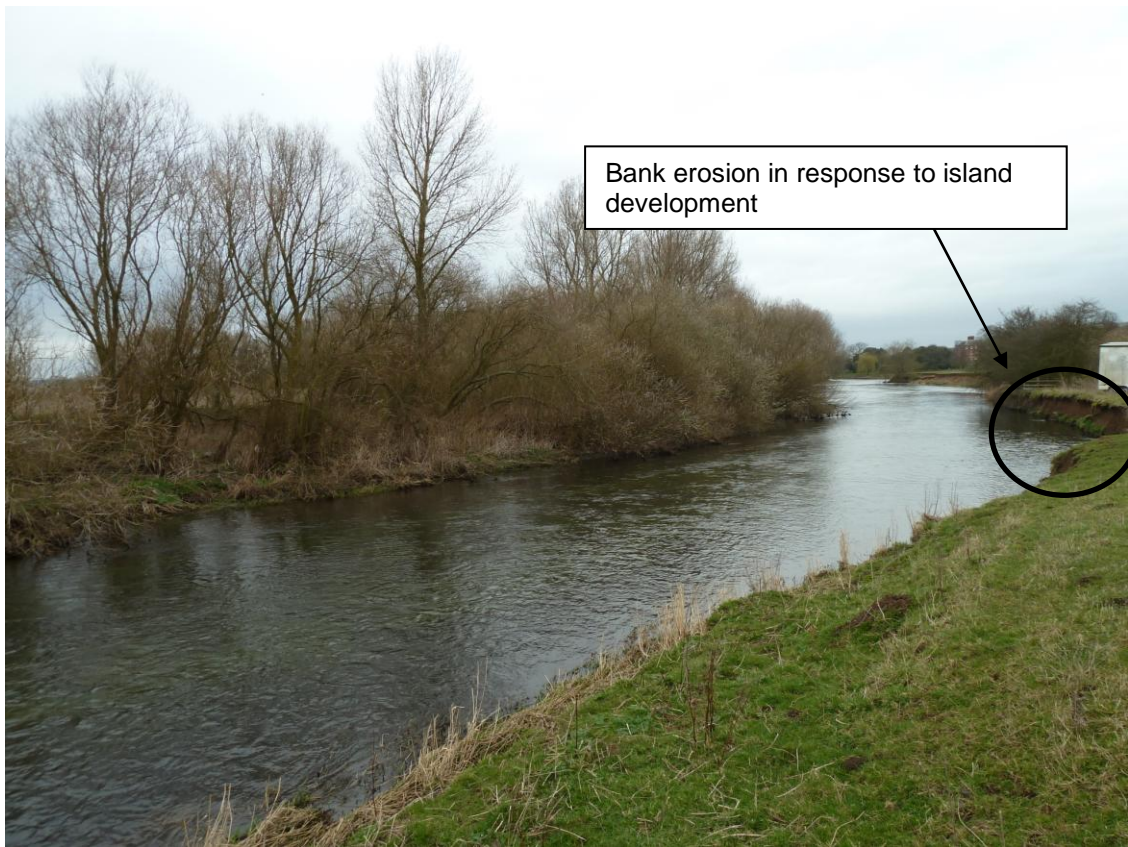
Figure 2-2: Island morphological feature

Morphological Feature Type	Sediment /Flow/ Vegetation Types	Feature Approximate Dimensions
Island	Generally composed of gravels, infilled with fine sediment Riffle entrance on both channels. Erosion on outer banks Stabilised through mature vegetation growth	Length ~75m Width - max ~20m Depth ~0.5-1.0m above low flow water level

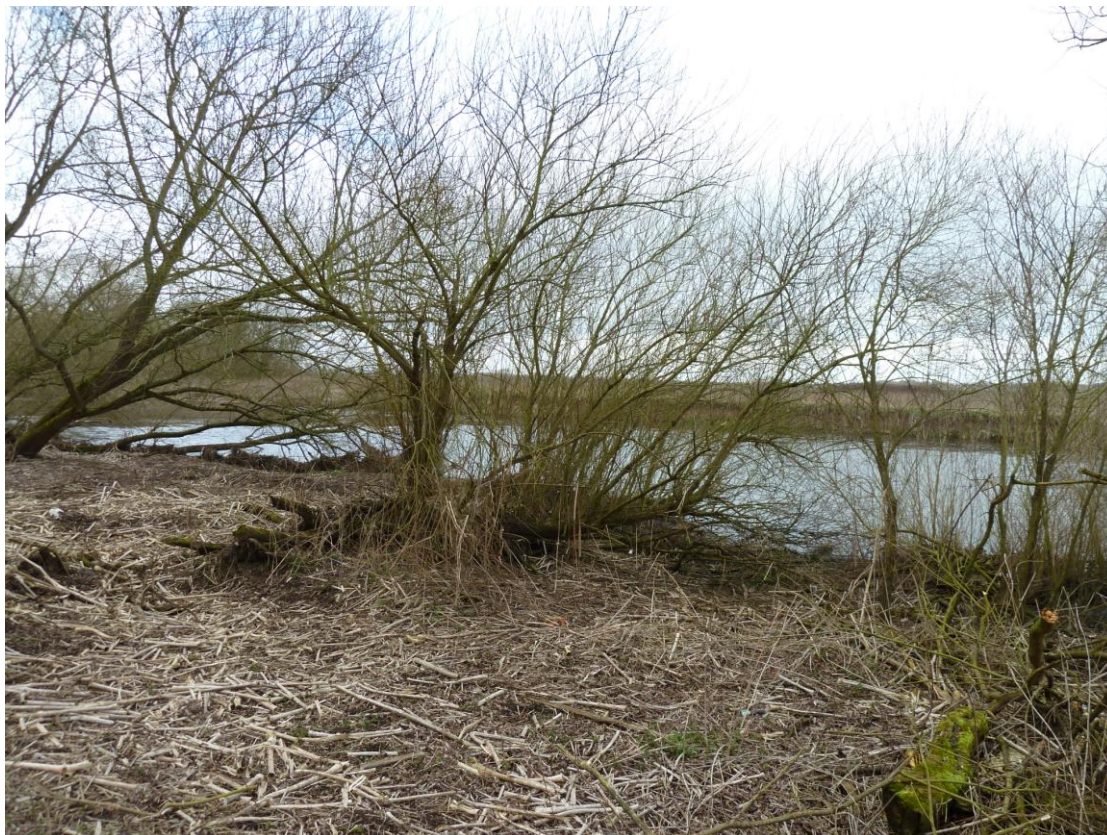
Figure 2-3: Point bar analogue information

The identified analogue point bar feature shown in Appendix A shows the hydromorphological and habitat diversity that could be created through reconnecting the point bar features throughout the study reach. These will also reduce bank erosion pressures identified along the study reach, in particular at the identified key point just downstream of Catton Hall on the left bank. This feature is demonstrated below in Figure 2-3. The lower level point bar is inundated frequently due to better connection with the channel, and there are local swales that have been scoured within the feature as a result.

Morphological Feature Type	Sediment /Flow/ Vegetation Types	Feature Approximate Dimensions
Point bar	Gravels infilled with fine sediment deposits Well wooded, mature vegetation that is frequently wetted Flow diversity at times of higher flow would include marginal deadwaters, standing water when flow recedes, chute channels.	Length ~ 150m Width ~ 50m Depth ~ level of point bar set at approx 0.5-1.0m above low flow water level

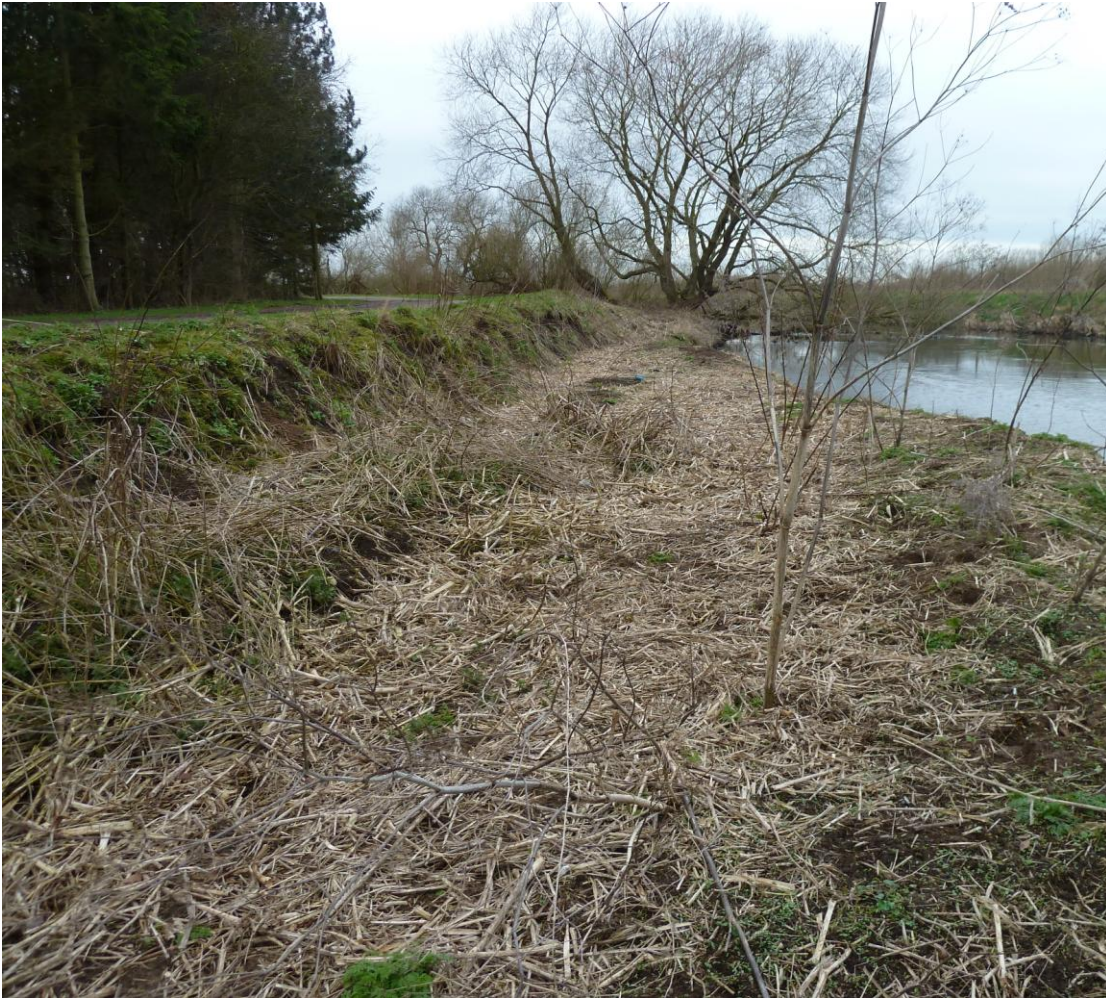
Figure 2-4: Natural berm analogue at Ryelands Nook

There is a natural berm development at Ryelands Nook that is approximately 0.75m above the low flow water level (Figure 2-4). This should be used as an analogue to indicate the functional level at which proposed lateral berms, islands and point bars should be introduced at.

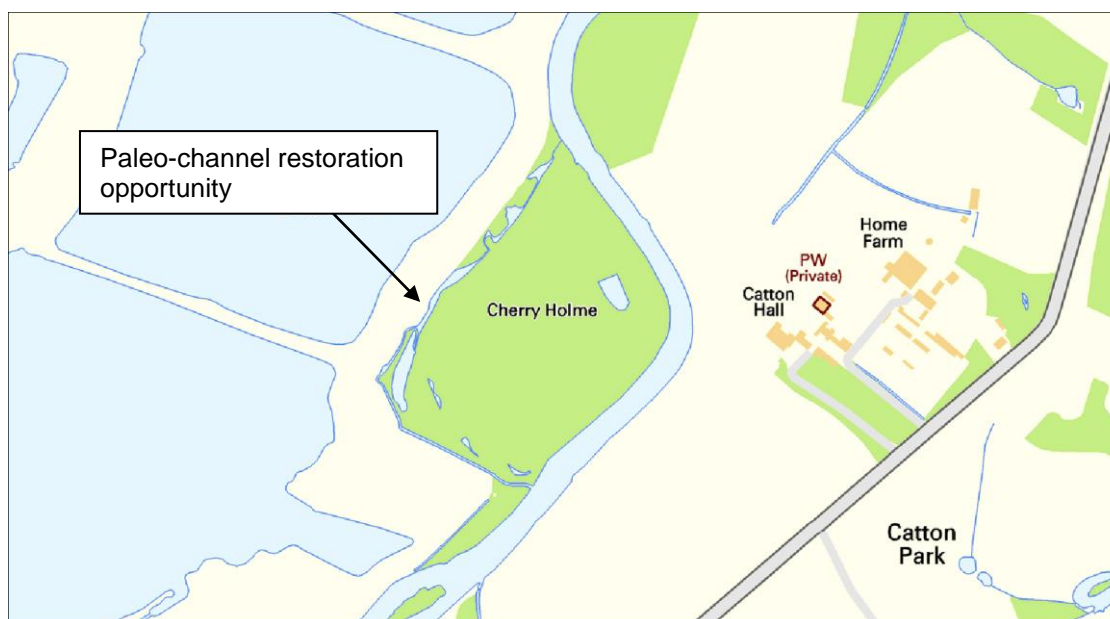
Figure 3-6: Paleo - channel at Cherry Holme

The area labelled Cherry Holme, adjacent to Catton Hall Estate over the right bank, was once an island and OS Maps show the previous route of the paleo-channel, which was abandoned between 1955-1964 (Figure 3-6). There was also a weir structure spanning half of the channel at the entrance to the paleo-channel where it branched off from the current main channel. There is an opportunity here to reconnect this paleo channel through excavation, which will improve the hydromorphic diversity across the meander. It will also relieve some of the erosion pressure on the right bank at Catton Hall Estate.

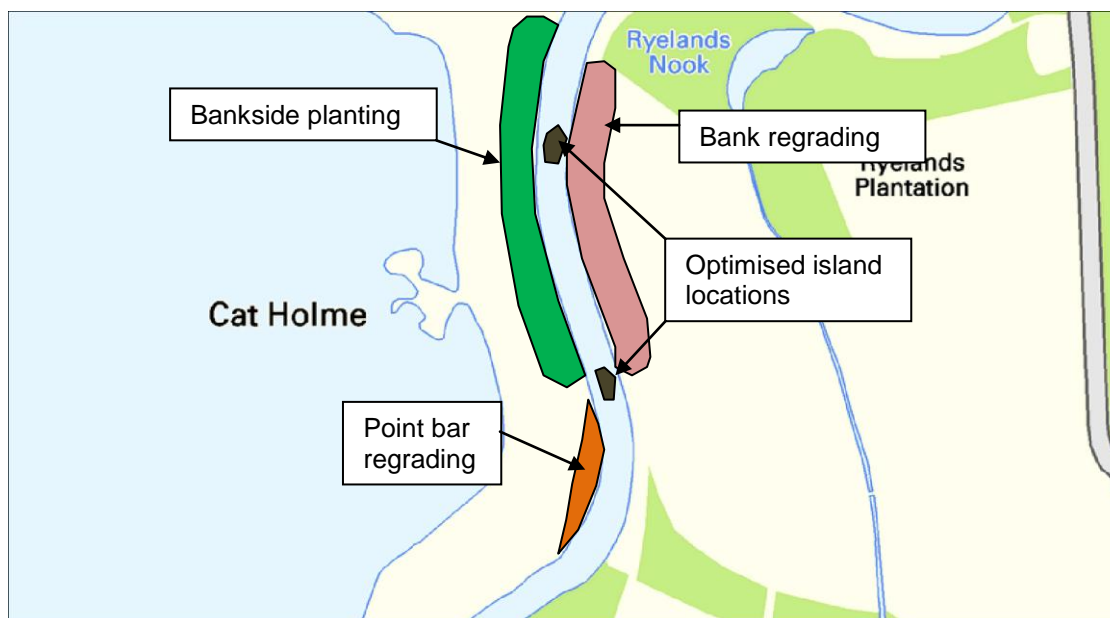
Figure 3-13: Proposed mid reach works

This section of the reach is experiencing bank slumping in response to the over-deepened channel. Stone pitching (rip rap) is protecting the toe of the left and right banks in numerous locations along this reach (Figure 3-12). There is potential to remove this stone pitching to allow a more natural bank profile to develop, particularly on the outer bank of the meander which currently exhibits a stepped profile rather than a steep faced bank that would normally occur under unprotected conditions. Significant lateral migration could be managed through bankside planting with woody species.

The proposed bank regrading of the right bank, downstream of the meander, should be undertaken as shown in Figure 3-11 and Figure 3-13 below. This would involve regrading the bank past the existing track into the floodplain (dropping immediate bankside levels by 1-2m). Therefore, the track would need to be moved if this is to be undertaken. It is not recommended to regrade the right bank at the outer bank of the meander bend, as this is working against the natural erosion pattern at this location.

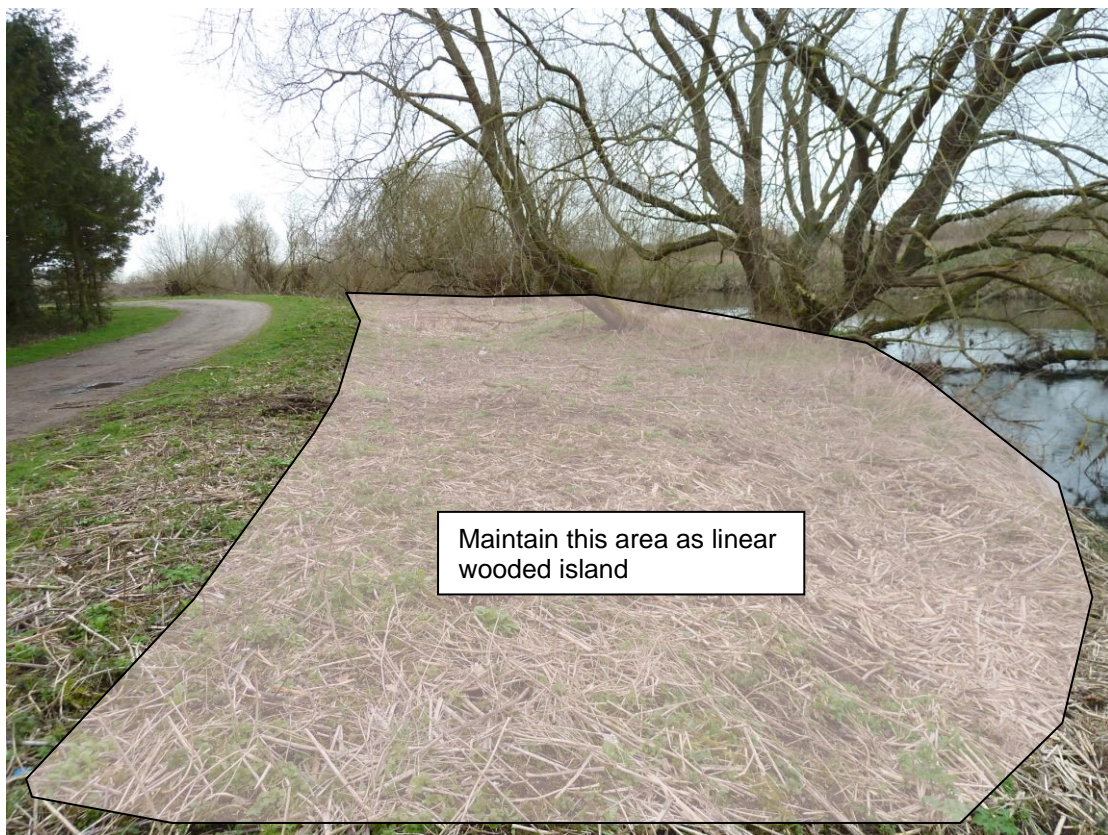
Figure 3-14: Point bar at Ryelands Nook

The right bank through this section of the Trent has been elevated through previous dumped channel material. The outer (left bank) is subsequently subject to heightened flow forces which presents an erosion risk if stone pitchings (riprap) are removed. The proposals here are to create a chute channel through the point bar on the right bank at Ryelands Nook to create linear island features which will maintain the local wooded vegetation to provide island stabilisation (Figure 3-14). Some bank regrading works will also be undertaken to reduce the bank levels and improve connectivity to the floodplain. This would require the current access

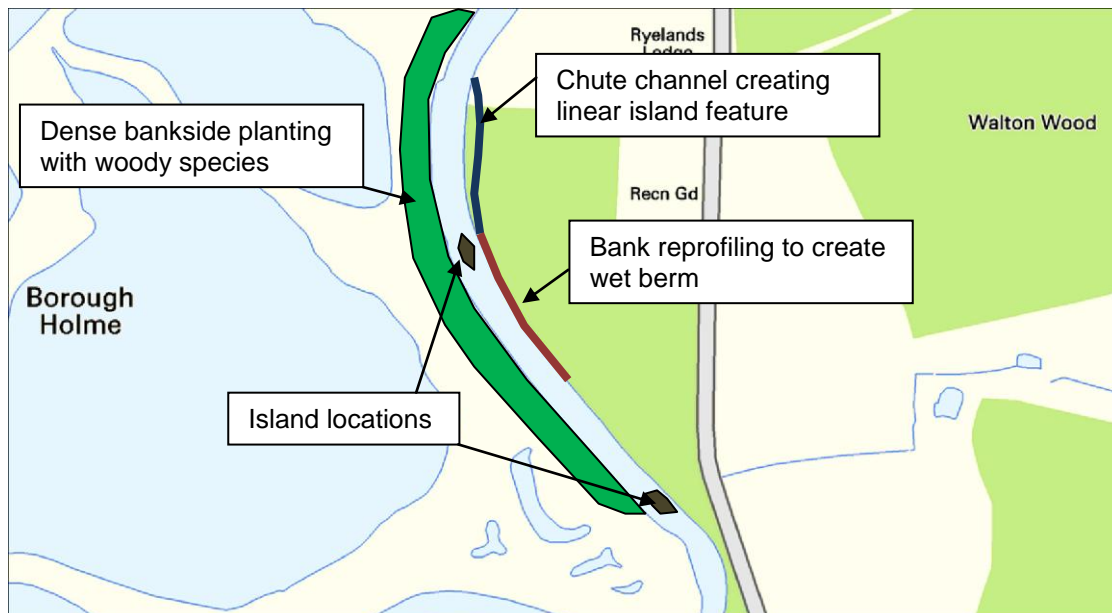
Figure 3-18: Downstream reach proposed work

This section is a uniform, over-deepened channel with relatively steep banks, protected by stone pitchings in places (Figure 3-17). This should be removed wherever possible with associated bankside planting to manage any lateral erosion risk. At the downstream end of the reach, a small, low level right bank lateral berm has developed, the location of this should be used as the extent (approximately 150m length) for the introduced wet berm area shown in Figure 3-18. This will ensure the introduced morphological features are working with the current river processes. The proposed islands for this section should be located based on the 2012s5829 - River Trent Naturalisation at Catton Estate - Final Report (v2.0).doc

channel planform and in shallower riffle areas, again, to ensure it is working with the current river processes. The optimised locations for these are shown in Figure 3-18.

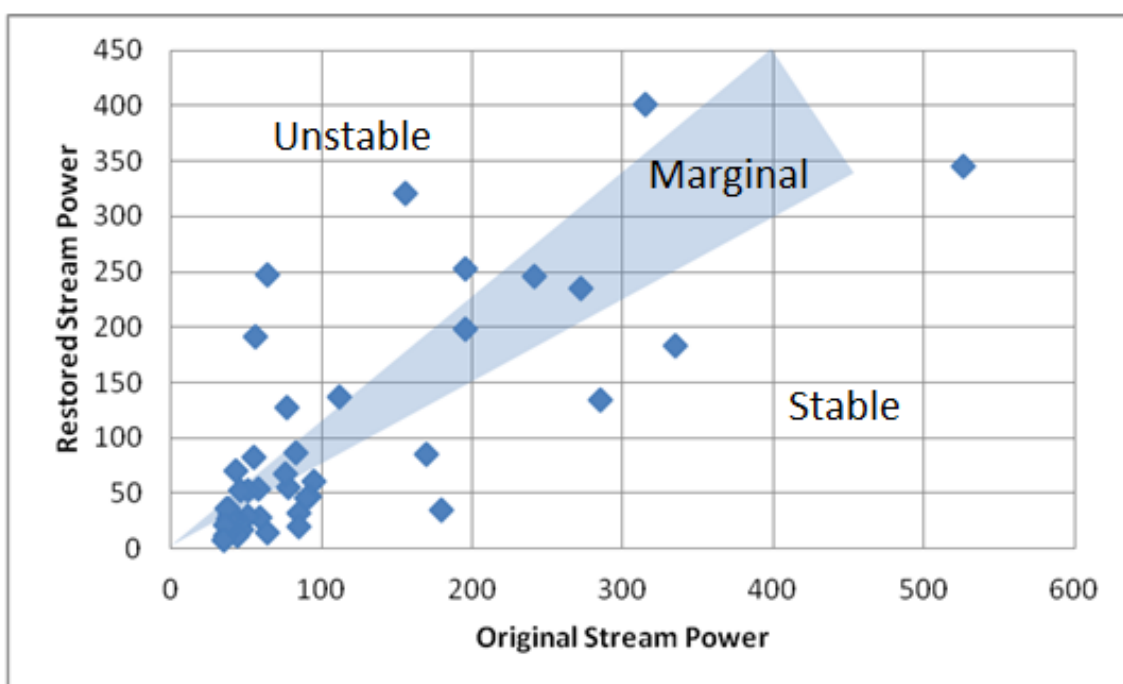
Figure 4-7 Alterations to stream power predictions following restoration on the River Trent at Catton.

Stream Power has been used as a measure to predict channel stability based on local slope and discharge characteristic and a threshold value of around 35 W/m² has been suggested for the instigation of channel change. This value must be treated with extreme caution as it is an average value derived from a highly variable dataset. However a review of the stream power results from the model for the Q95, Q50, Q10 and QMed flow along the River Trent through the Catton Estate (Table 4-5) suggest that even under the QMed flow the average values do not exceed this threshold. As such general dynamic stability is anticipated under the restored channel conditions. Figure 4-7 illustrates the change in steam power for model predictions exceeding 35 W/m² and an uncertainty band has been introduced to reflect the widespread variability on the calculation. Only in a few cases is the stream power expected to be increased significantly locally above present values. In these locations heightened erosion can be expected. These are already locations where erosion is presently occurring and should not be a cause for concern in this generally low energy system.

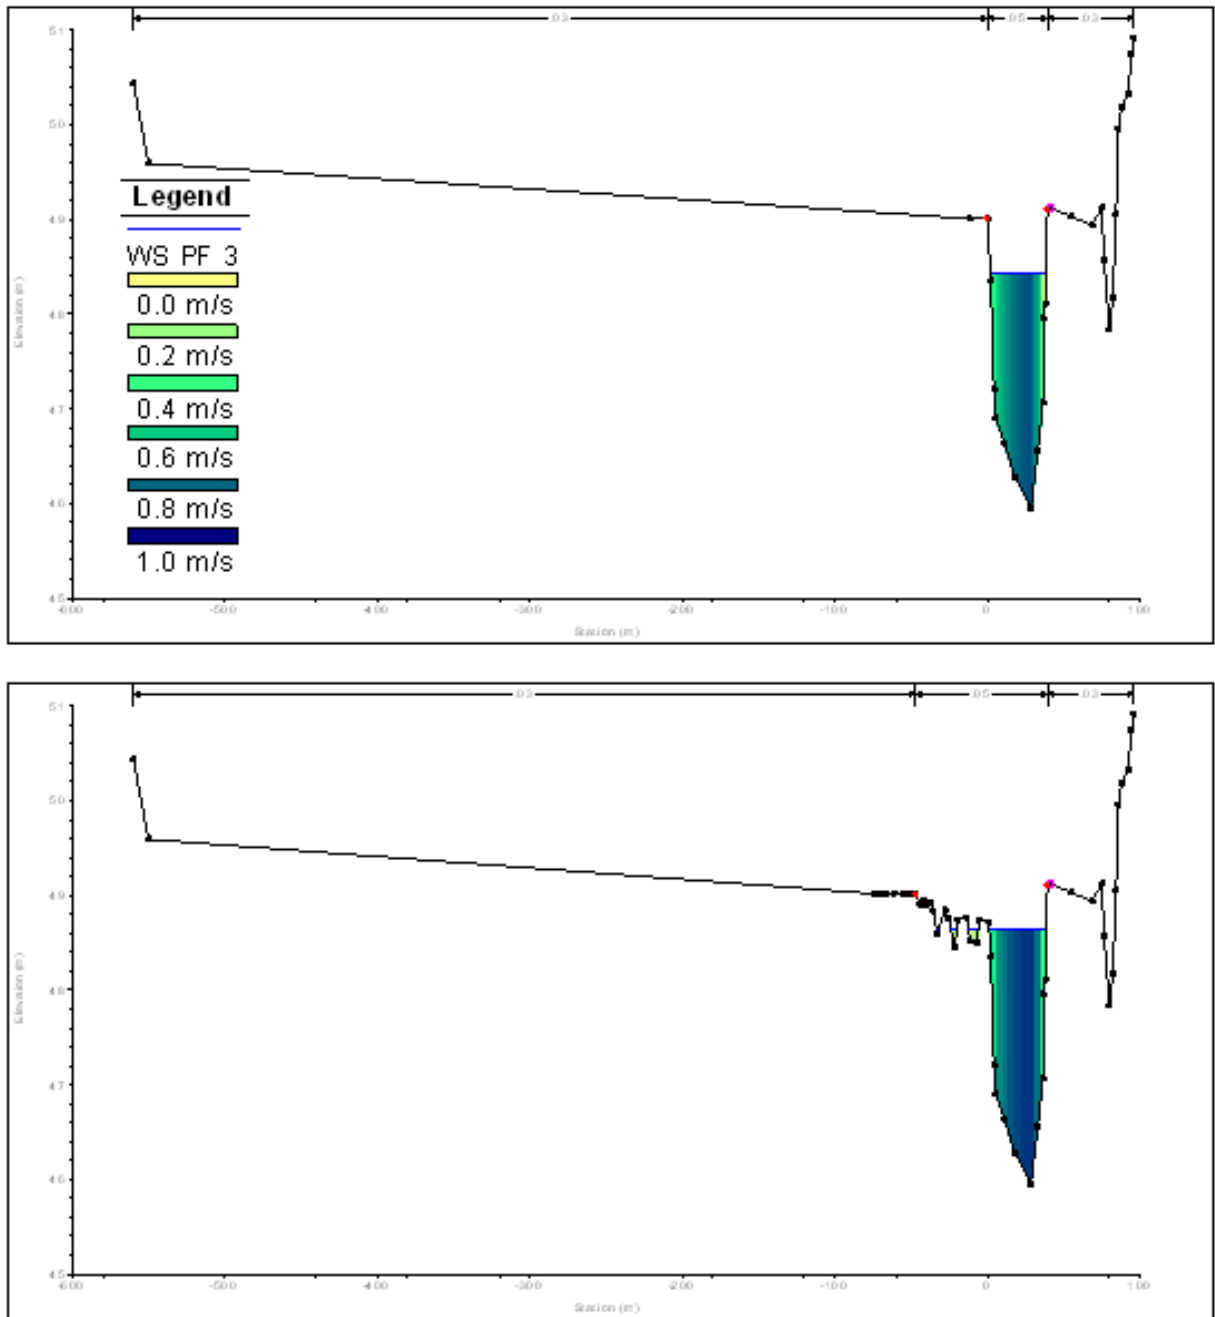
Figure 4-8 Anastomosed channel creation on the River Trent at Catton

Figure 4-8 to Figure 4-10 illustrate the local improvements to the hydraulic habitats at a cross-section level based on the proposed morphologic improvements. The winter high flow (Q10) model results are shown. The anastomosed channel network (Figure 4-8) has only a marginal effect on in-channel hydraulics but does open up significant ephemeral channel habitat. Floodplain scraping (Figure 4-9) reduces in-channel hydraulic energy, potentially reducing outer bank erosion and encouraging inner bank deposition. It also creates a new area of generally shallow low energy flow during elevated discharges. The effect of island creation is variable, Figure 4-10 shows how an island has caused preferential flow along one of the two distributary channels creating both lower and higher energy hydraulic habitats and forming a stable isolated in-channel deposit which will be colonised by vegetation and where succession will proceed without grazing pressure.

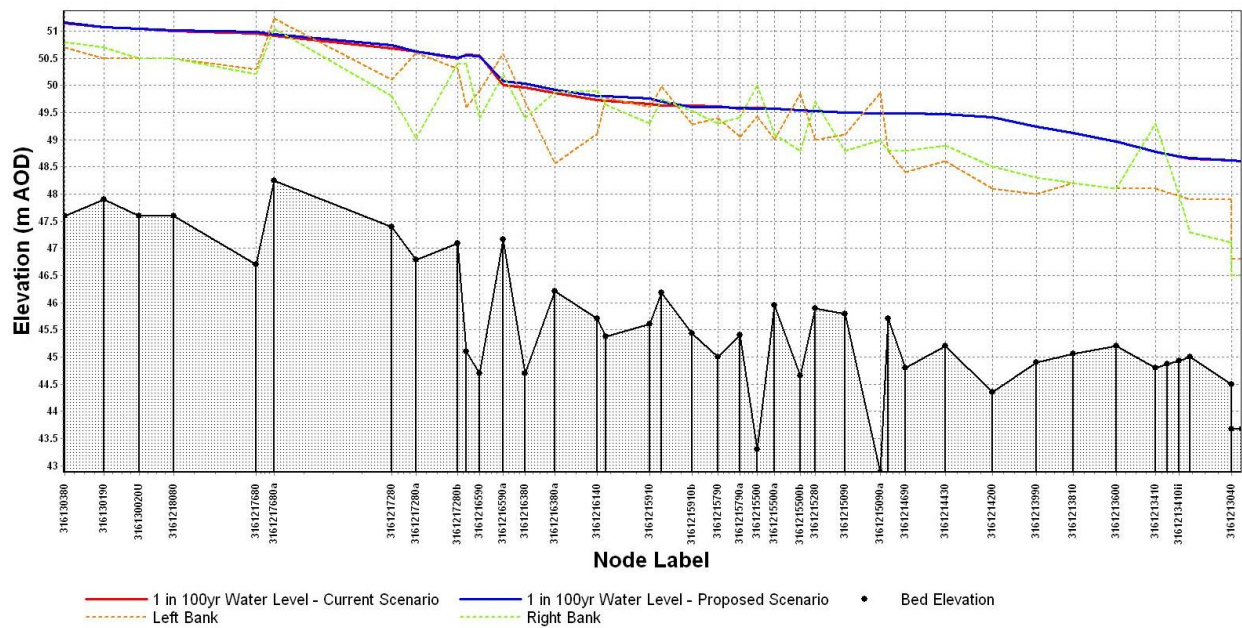
Figure 4-11 Comparison between existing and proposed water levels along the study reach

A comparison of pre and post restoration water levels has shown minimal differences. The maximum differences in water level within the channel which were found to occur were 0.09m (increase) and 0.02 (decrease). Within the floodplain the maximum difference in water level was 0.006m. These are considered to be minimal differences given the scale of flood events along the River Trent.

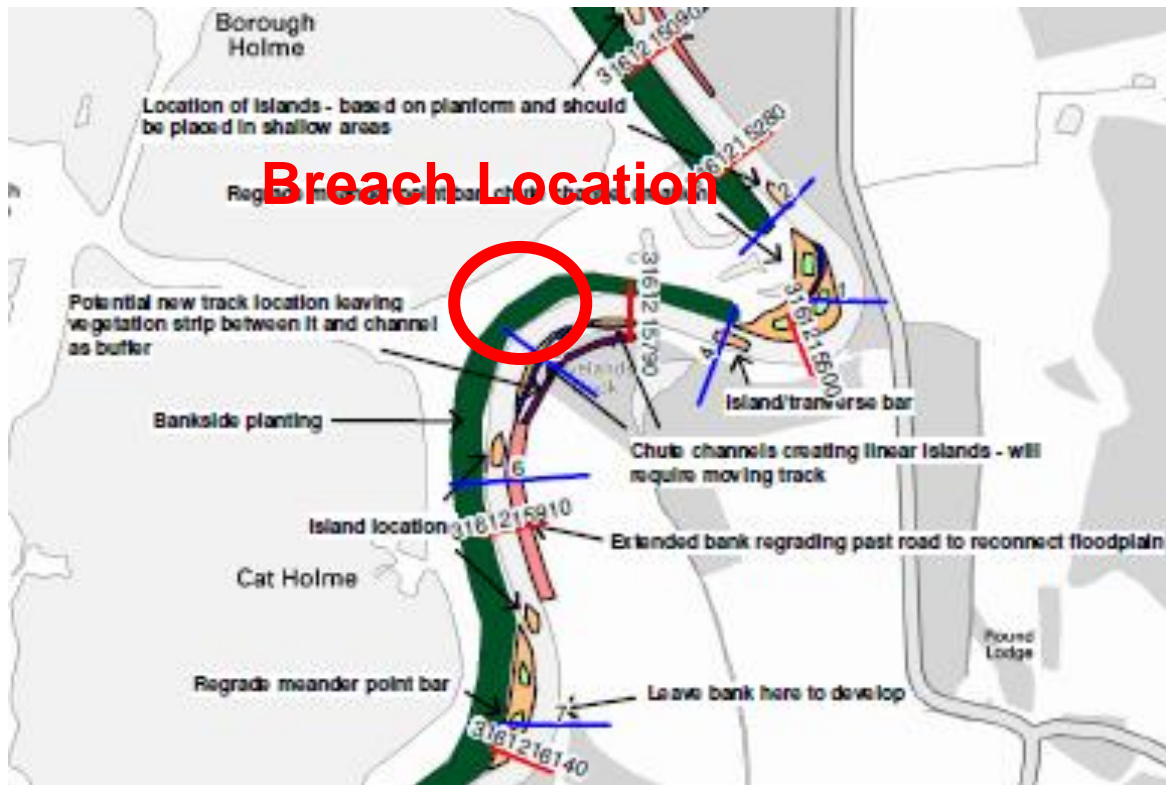
Figure 4-12 Location of Breach modelling

A separate model run was carried out to investigate the effect of a breach occurring along the left bank of the Trent into the Gravel Pit Lakes. The breach analysis was carried out using the 1 in 100 year flood event scenario. A 20m wide breach was modelled with bank levels reduced to ground level by approximately 1 metre.

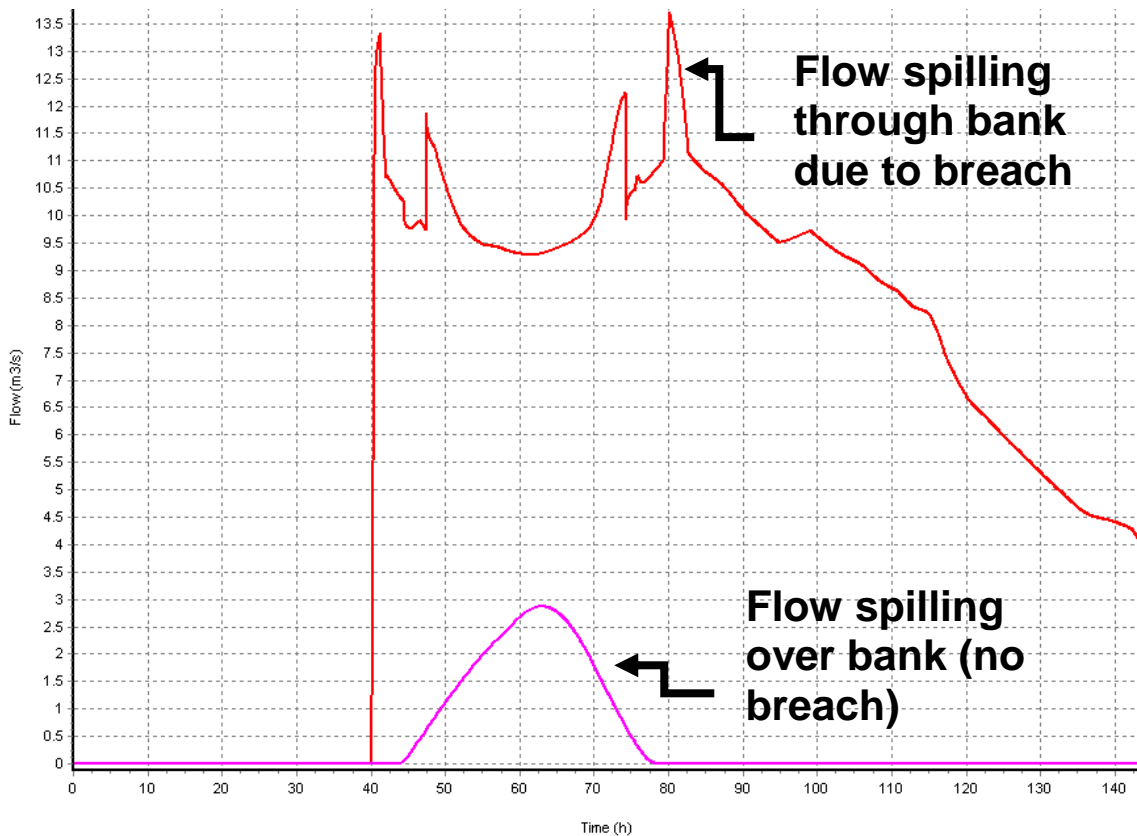
Figure 4-13 Comparison of overtopping and breach scenario flows

No significant difference in floodplain or river levels was found as a result of the breach occurring. An increased amount of flow was observed entering the floodplain as a result of the breach, however, increased flow leaving the floodplain area and re-entering the river was found at other location which balanced any effect, hence the limited difference in levels.
